DIAGNOSIS GUIDE

TRANSMISSION CONTROL UNIT

**ALL RELEVANT INFORMATION
IN ONE GUIDE**

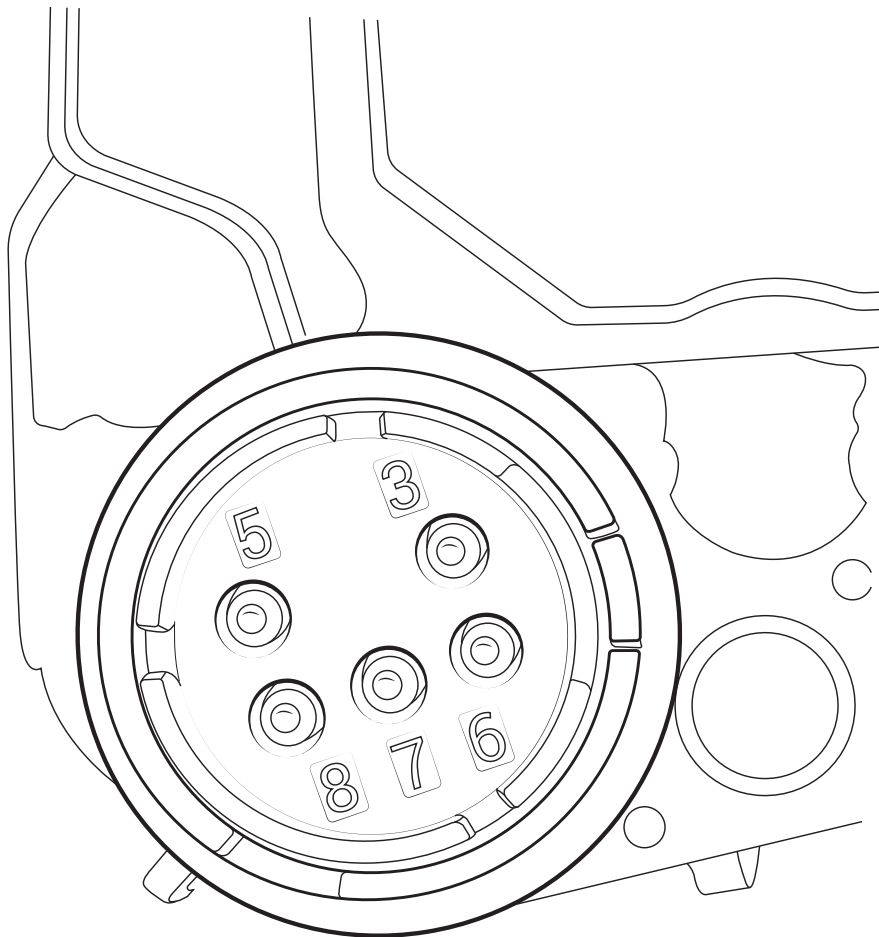
PIN ASSIGNMENT

Pin 3	K-line
Pin 5	CAN high
Pin 6	Power supply 12V +30
Pin 7	Ground 31
Pin 8	CAN low

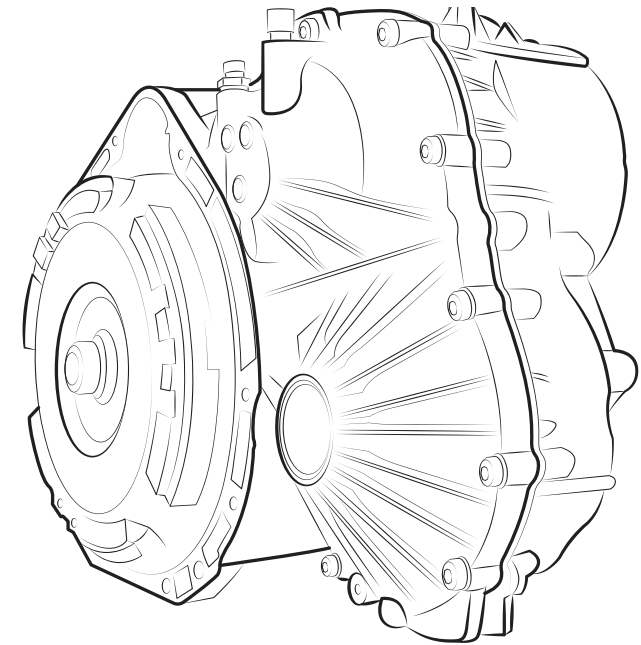
The Mercedes-Benz 722.7 gearbox with torque converter

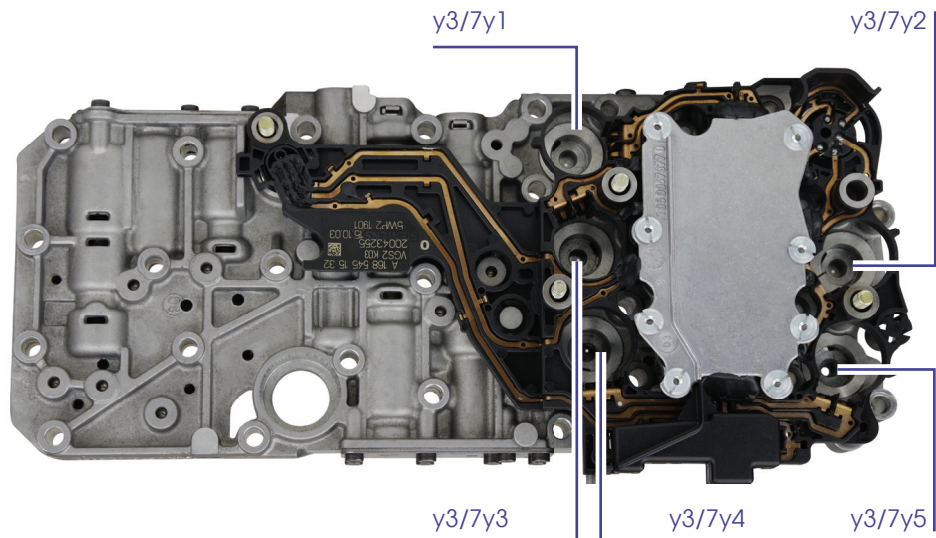
Actuator	Function
Y3/7y1	Control valve "for 1st and 4th gear"
Y3/7y2	Control valve "for 3rd gear"
Y3/7y3	Control valve "for 2nd, 5th and "R" gears"
Y3/7y4	Control valve for lock-up
Y3/7y5	Shift valve

4 of the 5 control valves in this Mechatronic are of the normally closed solenoid type. This means that the valves are closed when de-energised and do not allow any liquid to pass through. This means that control valves Y3/7y1, Y3/7y2, Y3/7y3 and Y3/7y4 can be exchanged without penalty.

Valve Y3/7y5 is another case. This is not a control valve, but a shift valve: the valve can only be opened to the maximum or closed to the maximum. In addition, this valve works with a different voltage.

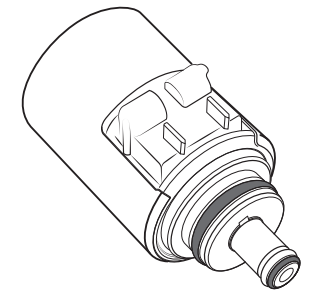
A normally-closed-solenoid.

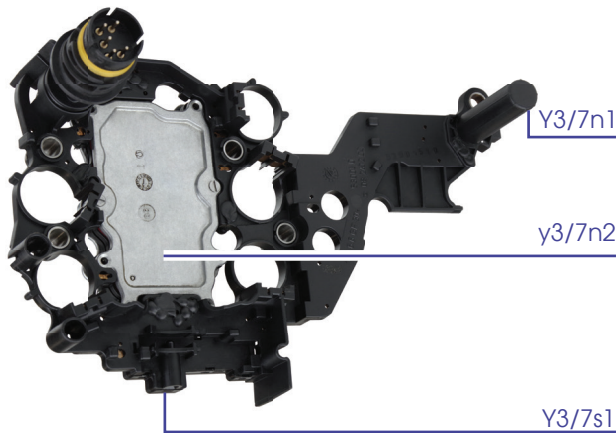
Sensor	Function
Y3/7n1	Speed sensor
Y3/7n2	Control module
Y3/7s1	Starter lockout

This type of TCU is relatively simple: 1 plug, 1 speed sensor, 1 switch for the starter lockout and 1 central control module.

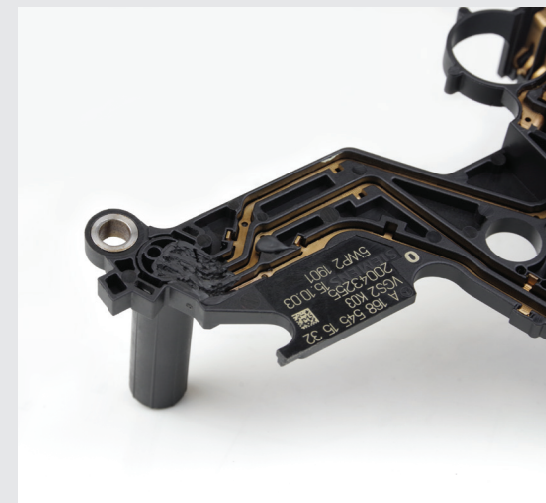
If live data are not available, the operation can also be measured via the copper tracks at the rear of the speed sensor. Use a multimeter for this. Between track 1 and track 3, the voltage will change between 0 volts and 5 volts each time a magnetic screwdriver is moved past the sensor.

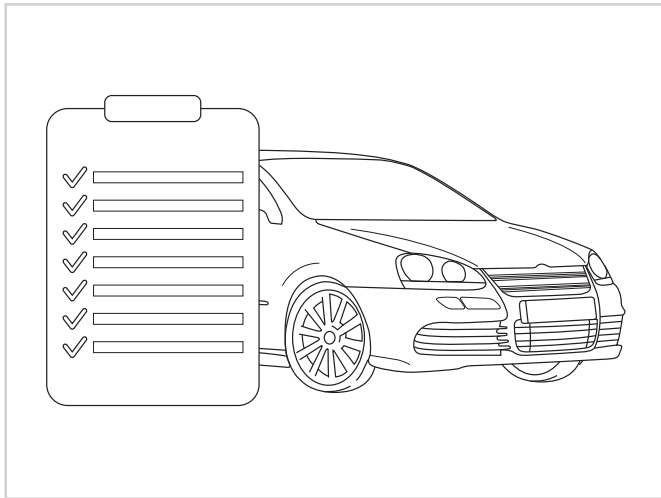
Preparation

1. Apply the car's handbrake.
2. Set the gearbox to "P".
3. If there is a radio with a radio code, make sure the radio code is known before disconnecting the battery.
4. Remove the ground wire from the battery.
5. Remove the base plate.
6. Remove the plug from the Mechatronic: turn the outer ring anticlockwise.

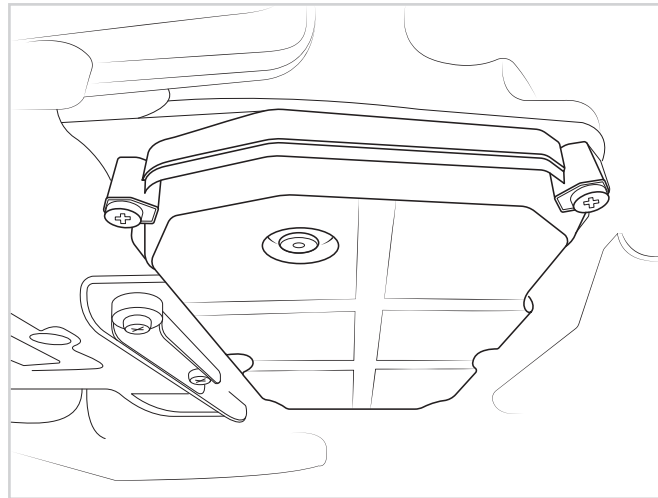
Sump pan disassembly

1. Place a drip tray with a capacity of at least 6 litres under the sump.
2. Unscrew the sump plug and drain the gearbox oil.

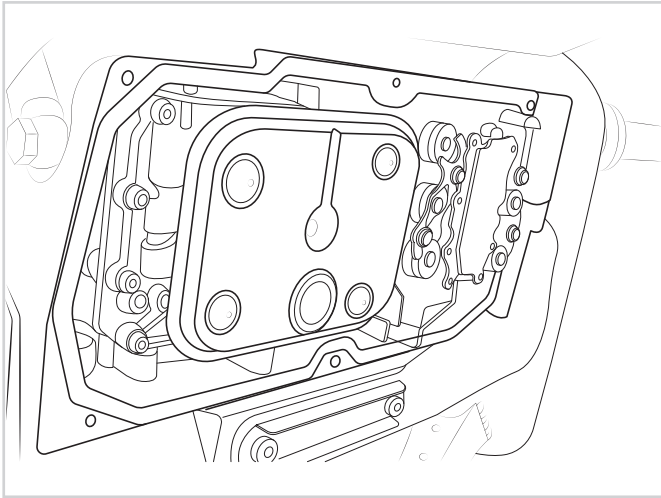
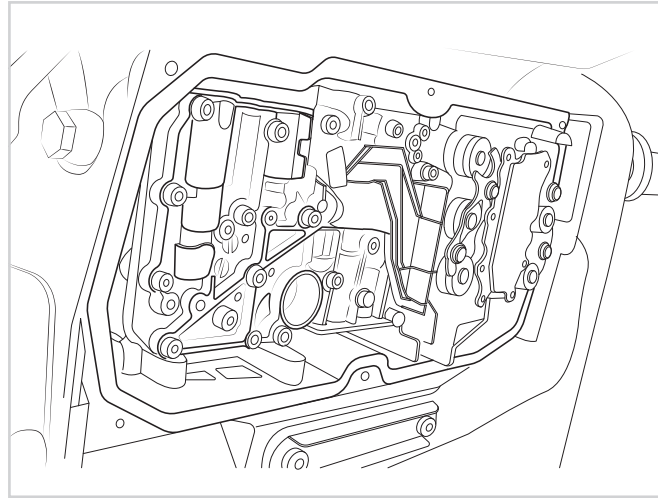
Mechatronic disassembly

1. Remove the oil filter. It is clamped in position without screws.
2. Loosen the 25 (!) bolts with which the Mechatronic is fastened. Ensure the Mechatronic is supported while doing this.
3. Lower the Mechatronic out of the gearbox. If it sticks, push the plug into the gearbox with little force.

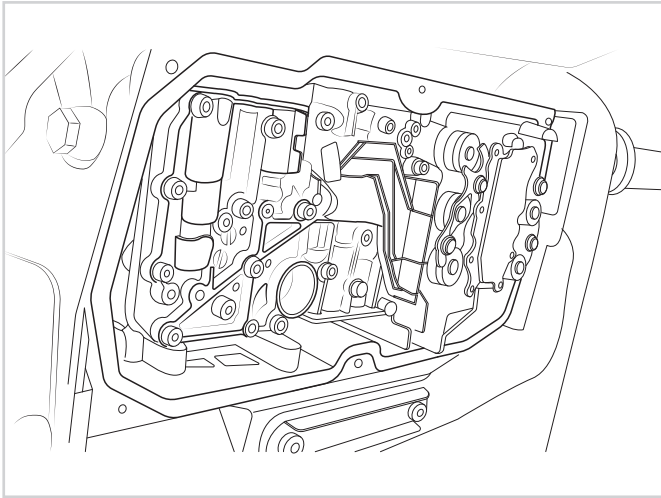
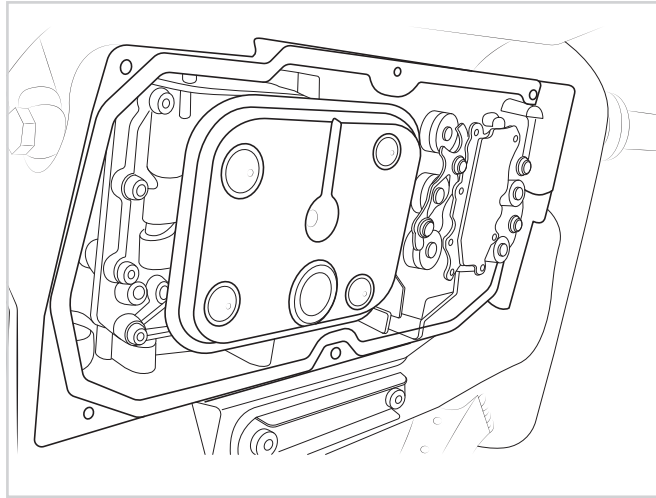
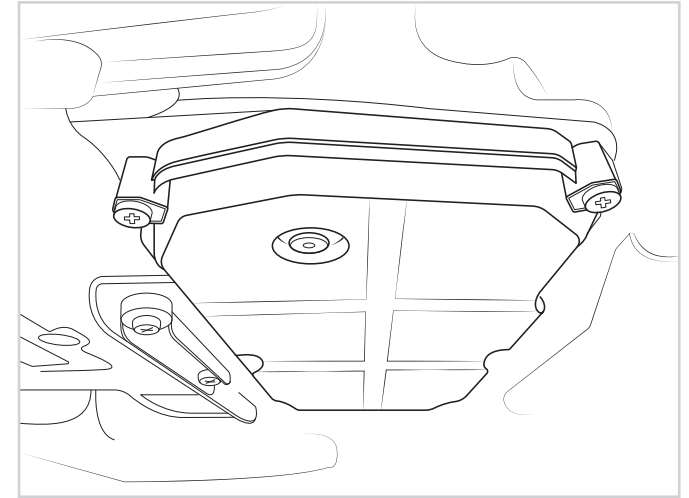
**Mounting the Mechatronic**

1. Before mounting, check the O-ring of the plug for damage. If in doubt, replace the O-ring.
2. Place the Mechatronic back into the gearbox. Pay close attention to the position of the plug and the control of the starter lockout.
3. Tighten the 25 (!) bolts crosswise. Tightening torque: 8 Nm.

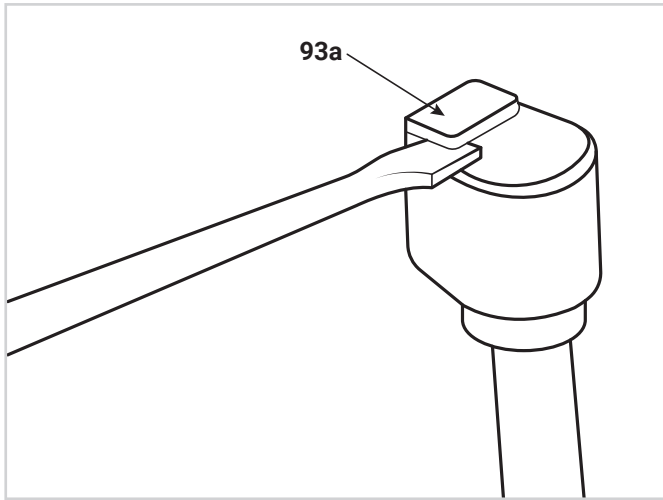
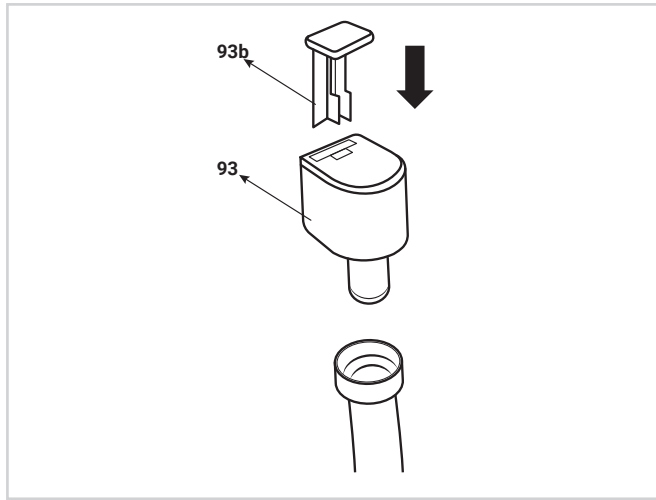
Adding gearbox oil

1. Remove locking plate "93a" from oil filler cap "93" and press down the remaining part of latch "93b" to remove it.
2. Remove oil filler cap "93" and first top up the gearbox with 3 litres of oil (MB 236.10 recommended).

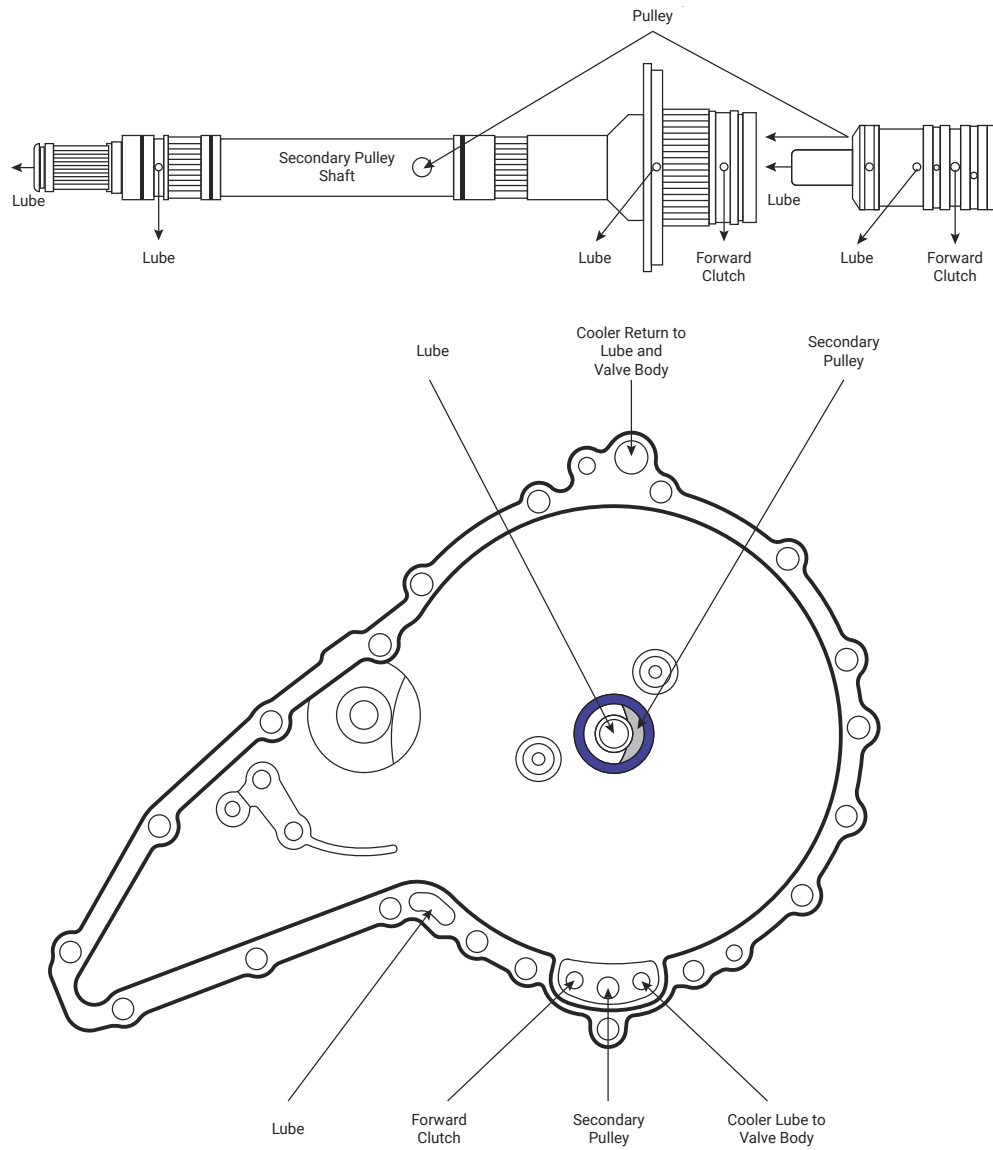
CRITICAL AREAS FOR MECHANICAL WEAR IN THE GEARBOX

If there is any contamination, check the gearbox thoroughly for mechanical wear/damage. The image below shows where the critical points are located.

In addition, always check the sensors for contamination by metal particles. This can also be a thin grey (greasy) layer. It may interfere with the sensor function. If there is any contamination, check the gearbox thoroughly for mechanical wear/damage, as described earlier in "The Mechatronic in detail". Then clean the sensors.

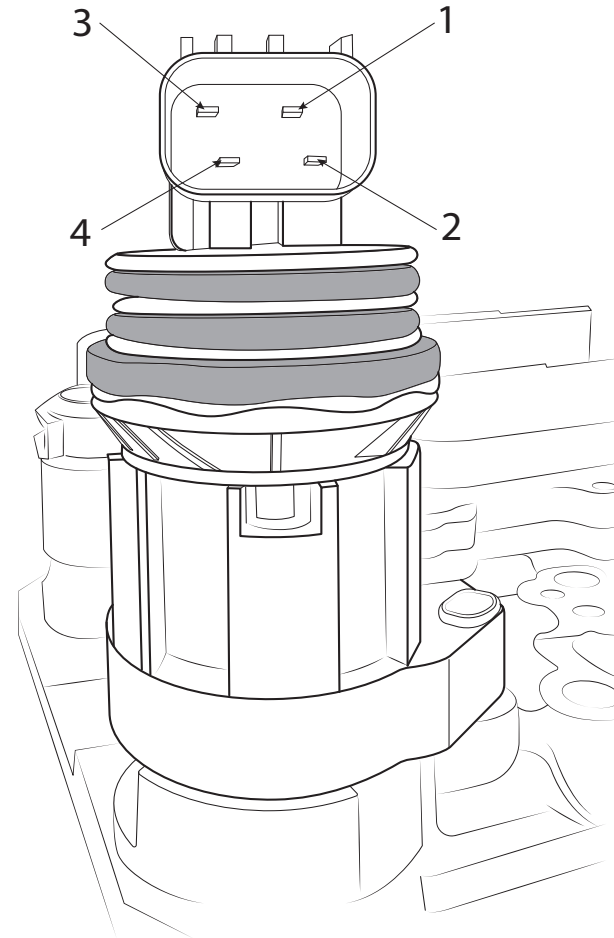
Pin 1	CAN low
Pin 2	CAN high
Pin 3	Ground 31
Pin 4	Power supply 12V +30

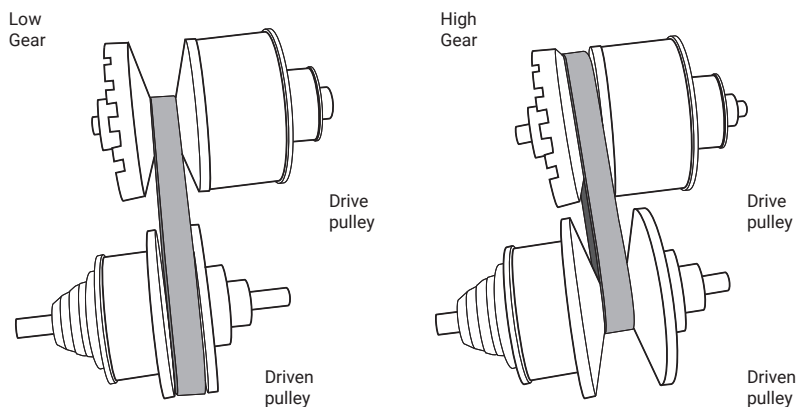
The adjustment of the pulley halves to a lower gear ratio.

The movable primary pulley half adjusts the gear ratio. As this movable primary pulley half moves towards the static primary pulley half, the secondary adjustable pulley half moves away from the static secondary pulley half and vice versa. The tension (pressure) of the tension belt is regulated by the hydraulically sliding secondary pulley half.

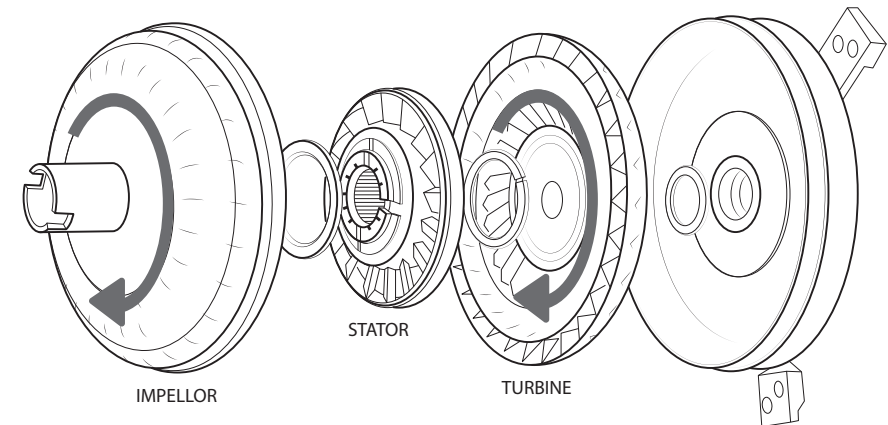
Exploded view torque converter.

A torque converter consists of a pump wheel (impeller), a stator and a turbine, and is filled with liquid. The pump wheel is directly connected to the engine block and will therefore always run at the same speed. As soon as the pump wheel starts to move, the centrifugal force pushes all the liquid to the outside of the enclosed unit. This causes the liquid to flow along the curved blades of the turbine, so that the turbine will eventually rotate in line with the pump wheel. At low speeds, the liquid does not give enough pressure to get the turbine going, but at high speeds, efficiency of up to 90% can be achieved.

The stator is added to the system purely to enhance the liquid effect. The component has a one-way freewheeling function, so that the amplifying effect only occurs when the turbine needs to be brought up to speed.

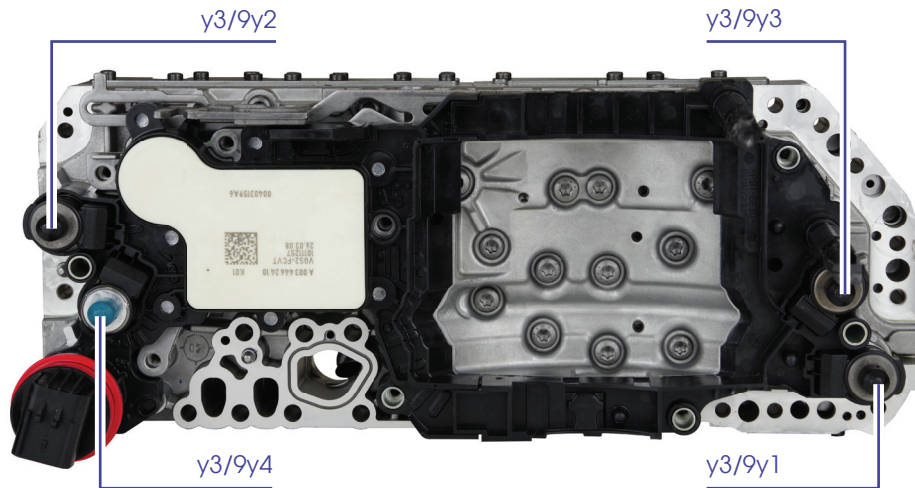
Actuator	Function
Y3/9y1	Control valve for primary pulley
Y3/9y2	Control valve for secondary pulley
Y3/9y3	Control valve for clutch
Y3/9y4	Control valve for lock-up

In order to control the amount of adjustment of the pulleys of the CVT, valves (solenoid valves) and speed sensors are required. The speed of both the driving pulley (engine side) and the speed of the driven pulley (differential side) is measured by 3 speed sensors. It is up to the TCU, the Temic VGS, to determine how much fluid (pressure) the solenoid valves can move to the pulleys to adjust the gear ratio:

To adjust the direction of rotation of the output shaft (and thus to be able to drive backwards) a gearbox with clutch is hidden in one of the pulleys. Valve **Y3/9y3** operates this clutch.

Finally, a valve is also used to operate/control the torque converter: **Y3/9y4**.

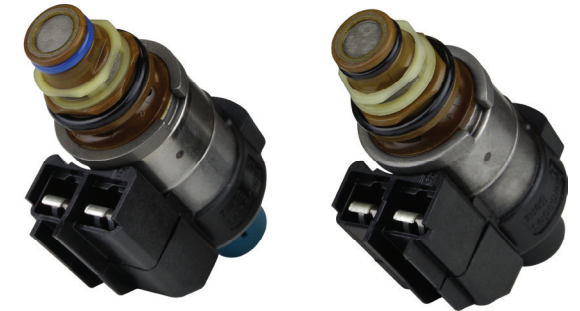
Two solenoid valves.

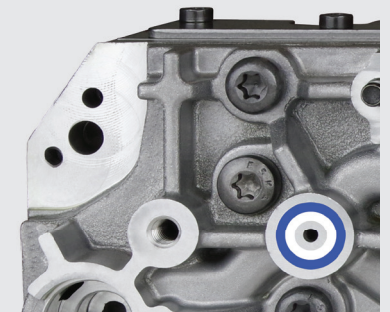
- › A damaged or missing blue-white O-ring. (see photo below)
- › Cracks in the hydraulic block
- › Contaminated gearbox oil

We would strongly advise you to check this carefully **every time** the Mechatronic is assembled or disassembled.

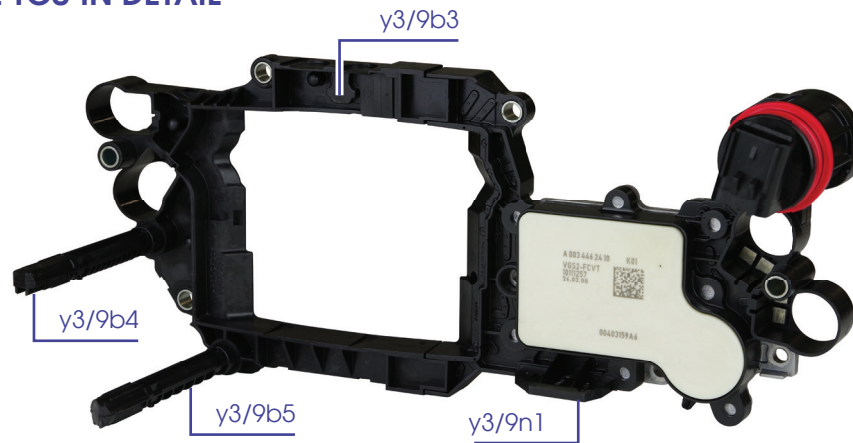
Sensor	Function
Y3/9n1	Position sensor switching position
Y3/9b3	Speed sensor primary pulley
Y3/9b4	Speed sensor secondary pulley
Y3/9b5	Speed sensor output shaft

The TCU is the brain of the 722.8 CVT. The desired transmission ratio is calculated in the TCU (Transmission Control Unit) based on the following variables: the engine torque, the engine speed, the driving speed, the position of the gear selector lever, the selected shift program and the CAN signals.

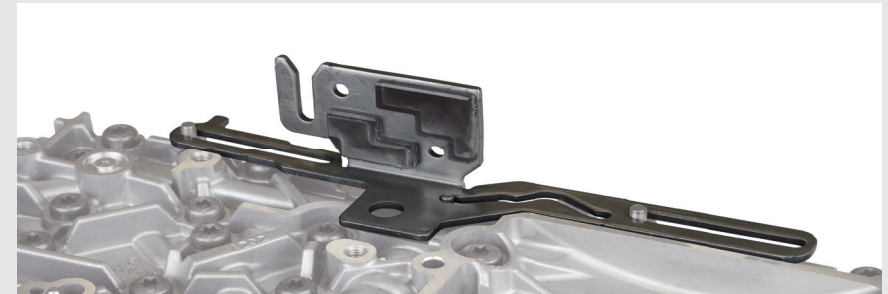
With sensor Y3/9n1, it is sufficient to hold the magnetic screwdriver in a certain position near the sensor. The sensor has 4 "fields". Each field displays its own shift position ("P", "R", "N" or "D"). It is also sufficient to leave the TCU mounted on the hydraulic block and to move the original fork (see picture) back and forth.

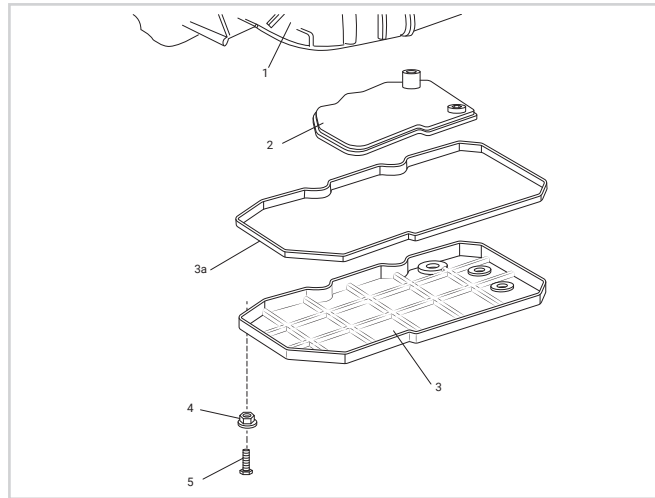
Draining the oil and removing the sump

1. Place a container that can collect at least 7 litres of oil under the gearbox.
2. Remove the plating on the underside of the engine compartment.
3. Remove the drain plug "31" from the CVT sump pan and allow the oil to drain into the container.
4. Loosen the screws "5" and remove the sump pan with gasket.

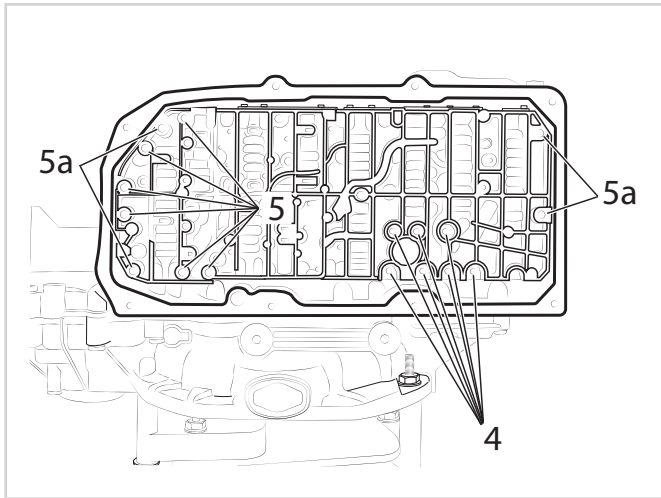
Removing the Mechatronic

1. Set the locking slider "2s" of the plug to the position shown above.
2. Press the lock "2v" and disconnect the plug.

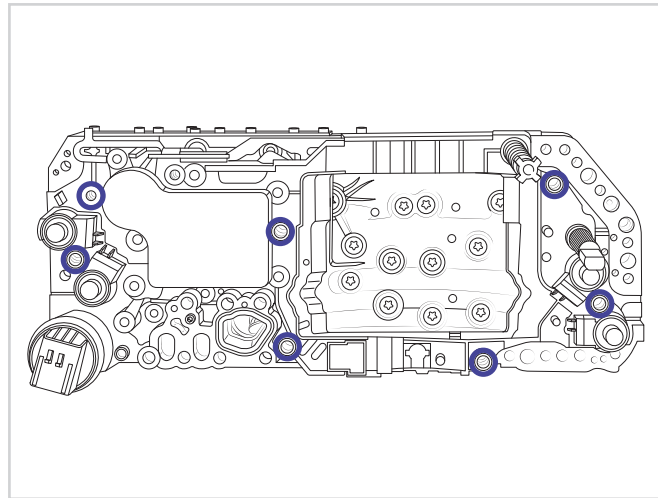
3. Only remove screws "4" and "5" (not "5a"!) from the Mechatronic.
4. First support the Mechatronic and then remove the screws "5a" from the Mechatronic.
5. Now slowly lower the Mechatronic out of the gearbox.

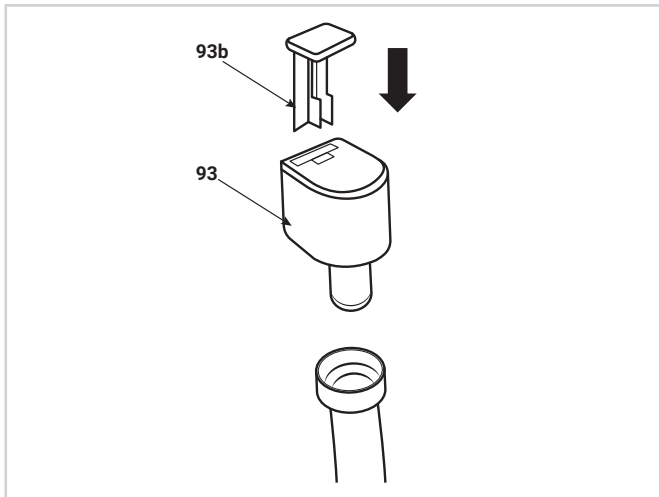
3. Check the oil level while the engine is idling (dipstick 168 589 01 21 00). Use the Star Diagnostic device to be able to read the current gearbox temperature.

The dipstick has 12 level dashes.

At 50 °C: Between the 2nd and 4th dash from the bottom

At 80 °C: Between the 5th and 7th dash from the bottom

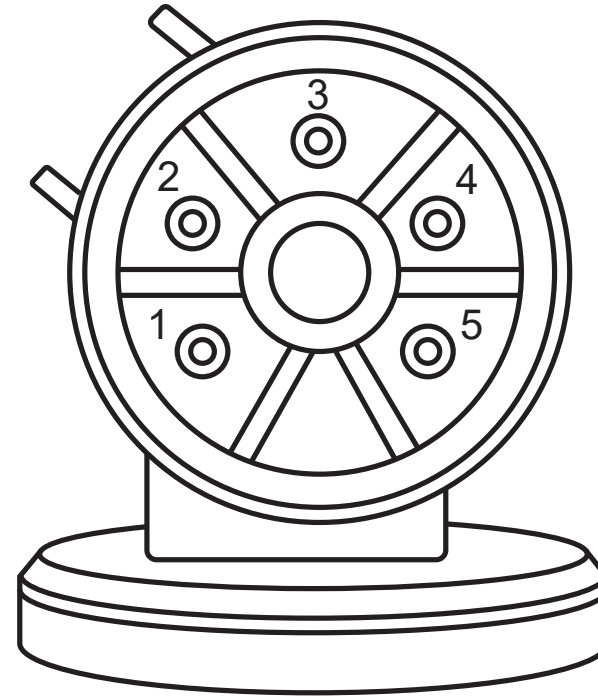
PIN ASSIGNMENT

Pin 1	CAN high
Pin 2	CAN low
Pin 3	Diagnostic line
Pin 4	Power supply 12V +30
Pin 5	Ground 31

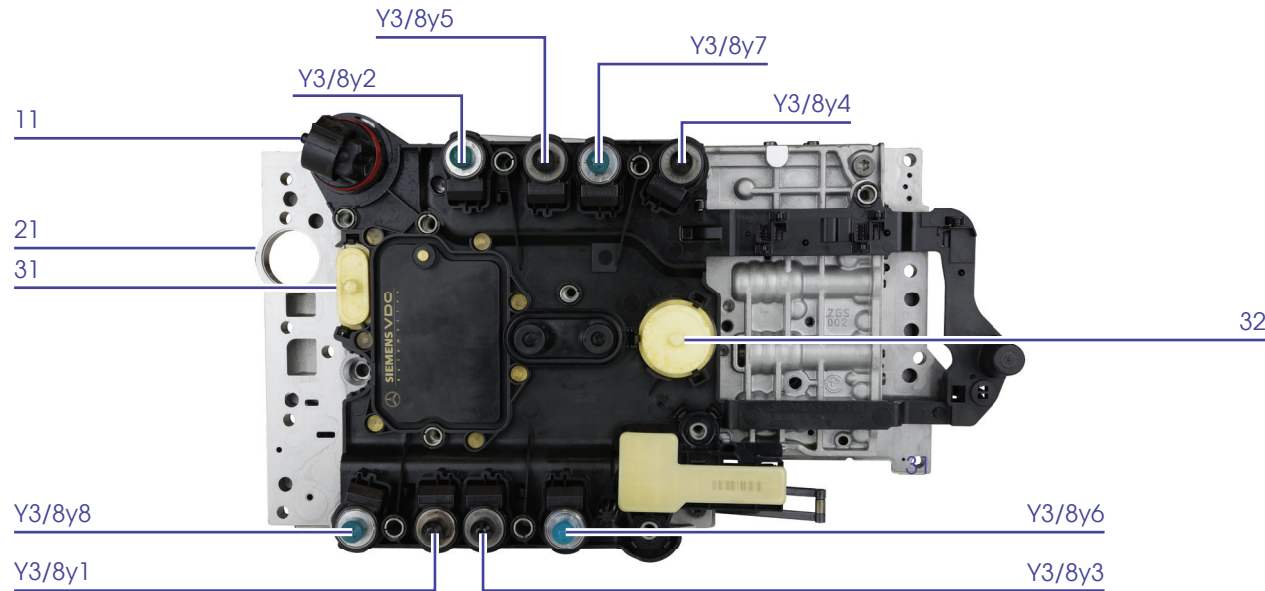
THE MECHATRONIC IN DETAIL

Part no.	Function
11	Plug
21	Hydraulic block / valve body, consisting of 2 parts and a partition panel
31	Oil level float 1
32	Oil level float 2
Y3/8y1	Control valve for general operating pressure
Y3/8y2	Clutch control valve K1
Y3/8y3	Clutch control valve K2
Y3/8y4	Clutch control valve K3
Y3/8y5	Brake control valve B1
Y3/8y6	Brake control valve B2
Y3/8y7	Brake control valve B3
Y3/8y8	Lock-up clutch control valve

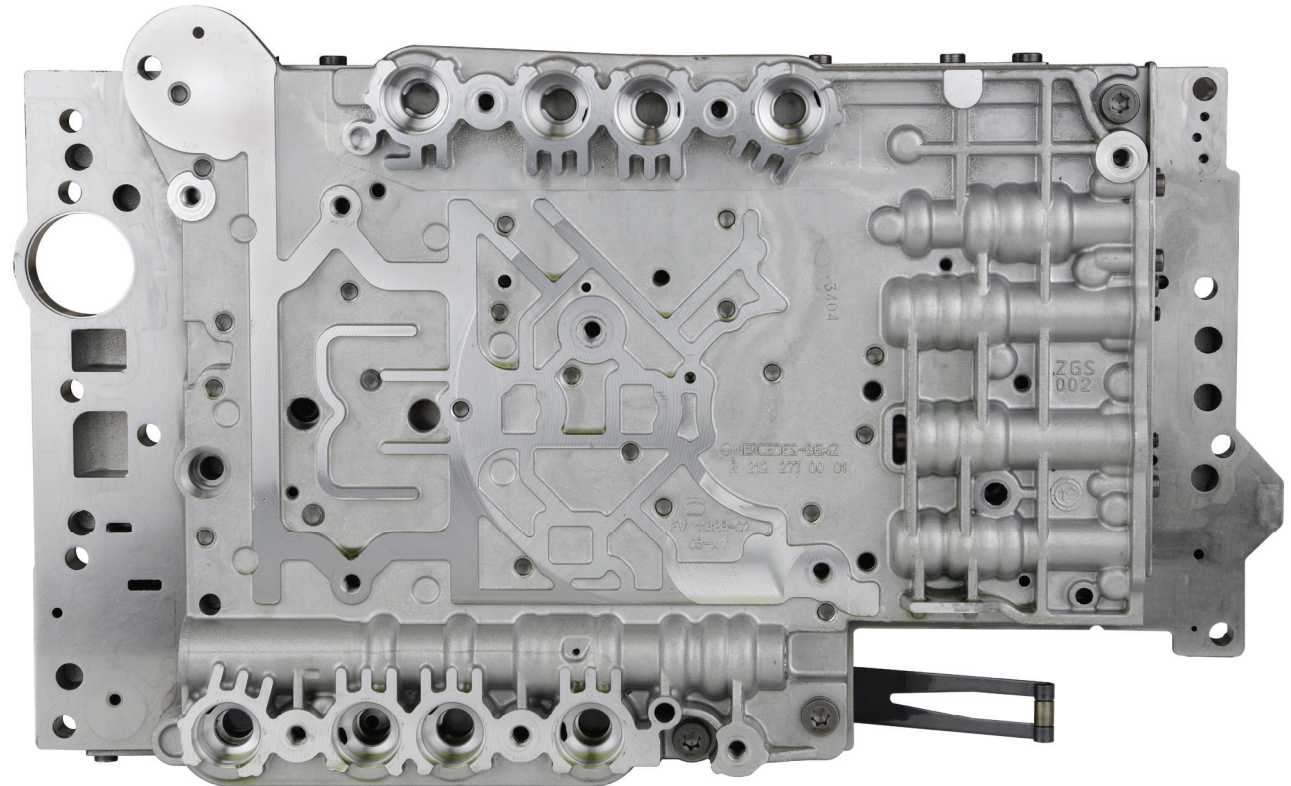
The valve body: a labyrinth of fluid lines, consisting of 2 metal housings and a dividing plate.

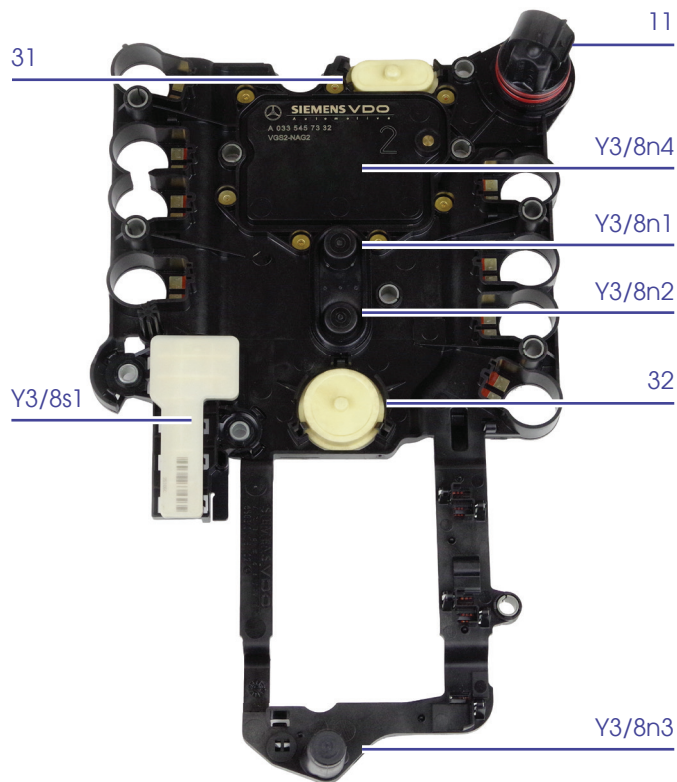
THE TCU IN DETAIL

At the moment of writing, there are 4 generations of 7G-tronic. The version number is indicated by a large number on control module Y3/8n4.

The first 2 generations in particular are known for their problems with the speed sensors. From generation 3 onwards, this has been considerably improved. Sensor defects therefore occur only sporadically in generation 3 and 4.

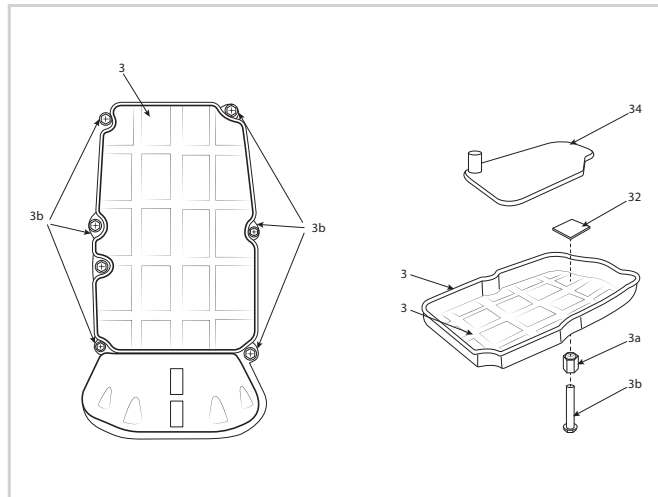
Draining the oil and removing the sump

1. Place a container that can collect at least 7 litres of oil under the gearbox.
2. Remove the plating on the underside of the engine compartment.
3. Unscrew the drain plug from the sump "3" and drain the oil into the container.
4. Loosen the screws "3b" and remove the sump pan with gasket.
5. Remove the filter "34": you can pull it straight down out of its seat.
6. Let the oil that flows out afterwards also run into the container.

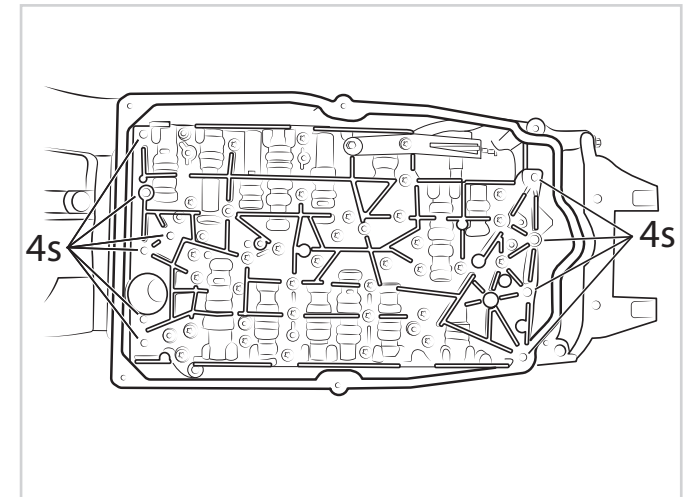
Removing the Mechatronic

1. Remove the heat shield that is placed over the TCU plug.
2. Unplug the power cord.
3. Support the Mechatronic and loosen the screws "4s".
4. The Mechatronic can now be removed by pulling it straight down and off the gearbox.

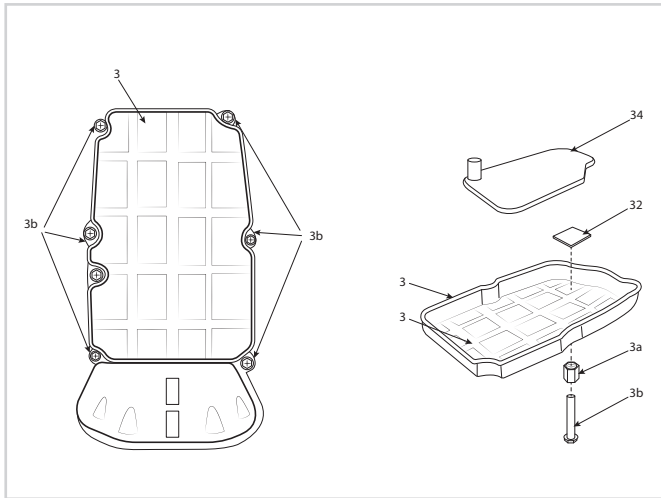
Mounting the sump

1. Install a **new** filter "34".
2. Install a **new** gasket "33" on the sump pan "3".
3. Place the sump pan "3" with gasket "33": tighten the screws to 4 Nm and then turn these another 180°.

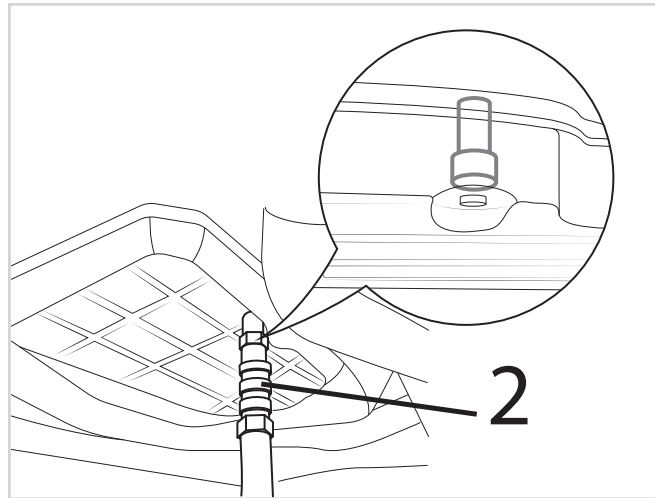
Adding gearbox oil

1. Mount the adapter "2" (special tool) in the hole of the sump pan.
2. Connect the oil filling device to the adapter "2".
3. Pump 6 litres of gearbox oil into the gearbox.
4. Start the engine.
5. When the engine is running, check the temperature of the gearbox oil. Use the Star Diagnostic device for this purpose.
6. Bring the gearbox oil to the correct temperature. To do this, keep the engine speed at 2500 rpm with the gearbox in position "P":

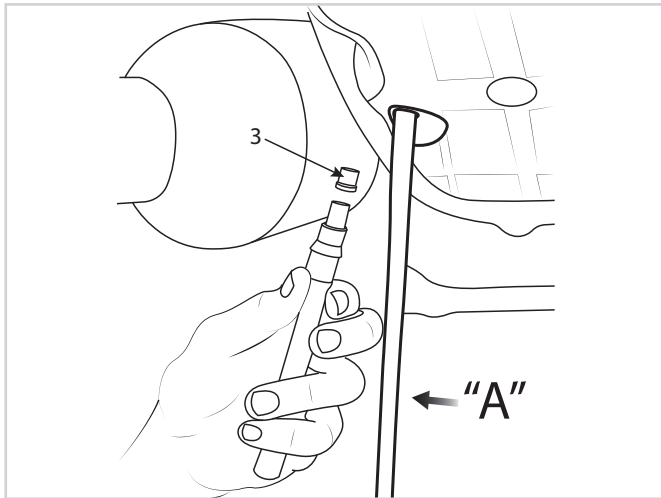
13. Remove the adapter "2". Excess oil now starts flowing out of the sump.

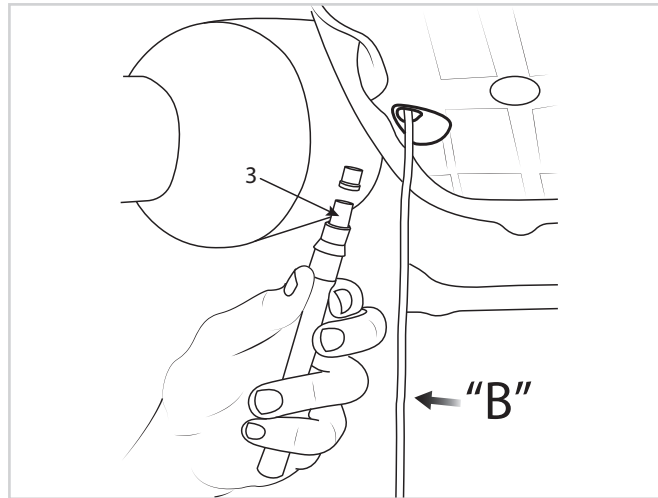
14. Wait until situation "B", before installing the sump plug "3" with a **new** sealing ring.

Tightening torque for the sump plug: 22 Nm.

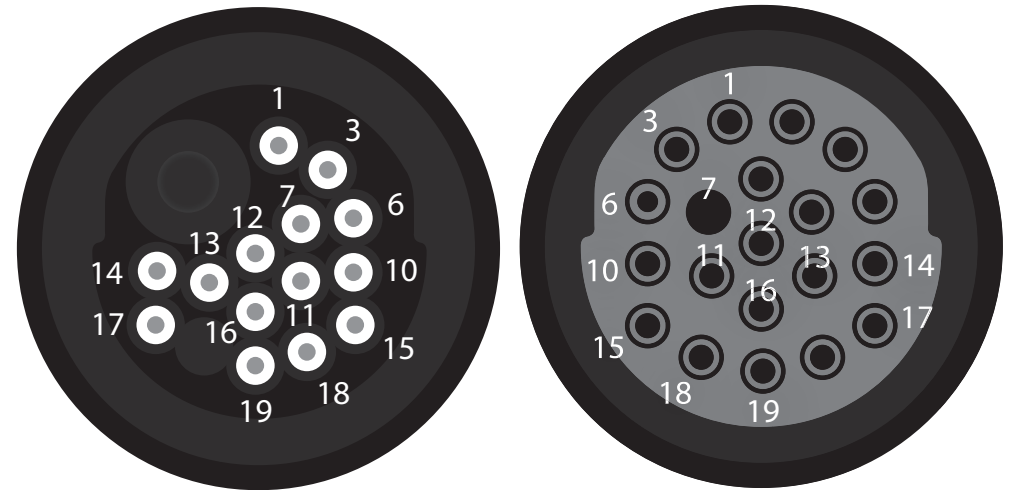
PIN ASSIGNMENT

Pin 1	K-line
Pin 3	Tiptronic tip -
Pin 6	Dashboard speed signal
Pin 7	-
Pin 10	CAN high
Pin 11	Power supply 12V +30
Pin 12	Reverse signal ("R")
Pin 13	Power supply 12V +15
Pin 14	Tiptronic tip +
Pin 15	CAN low
Pin 16	Ground 31
Pin 17	P/N signal (start control)
Pin 18	Power supply 12V +30
Pin 19	Ground 31

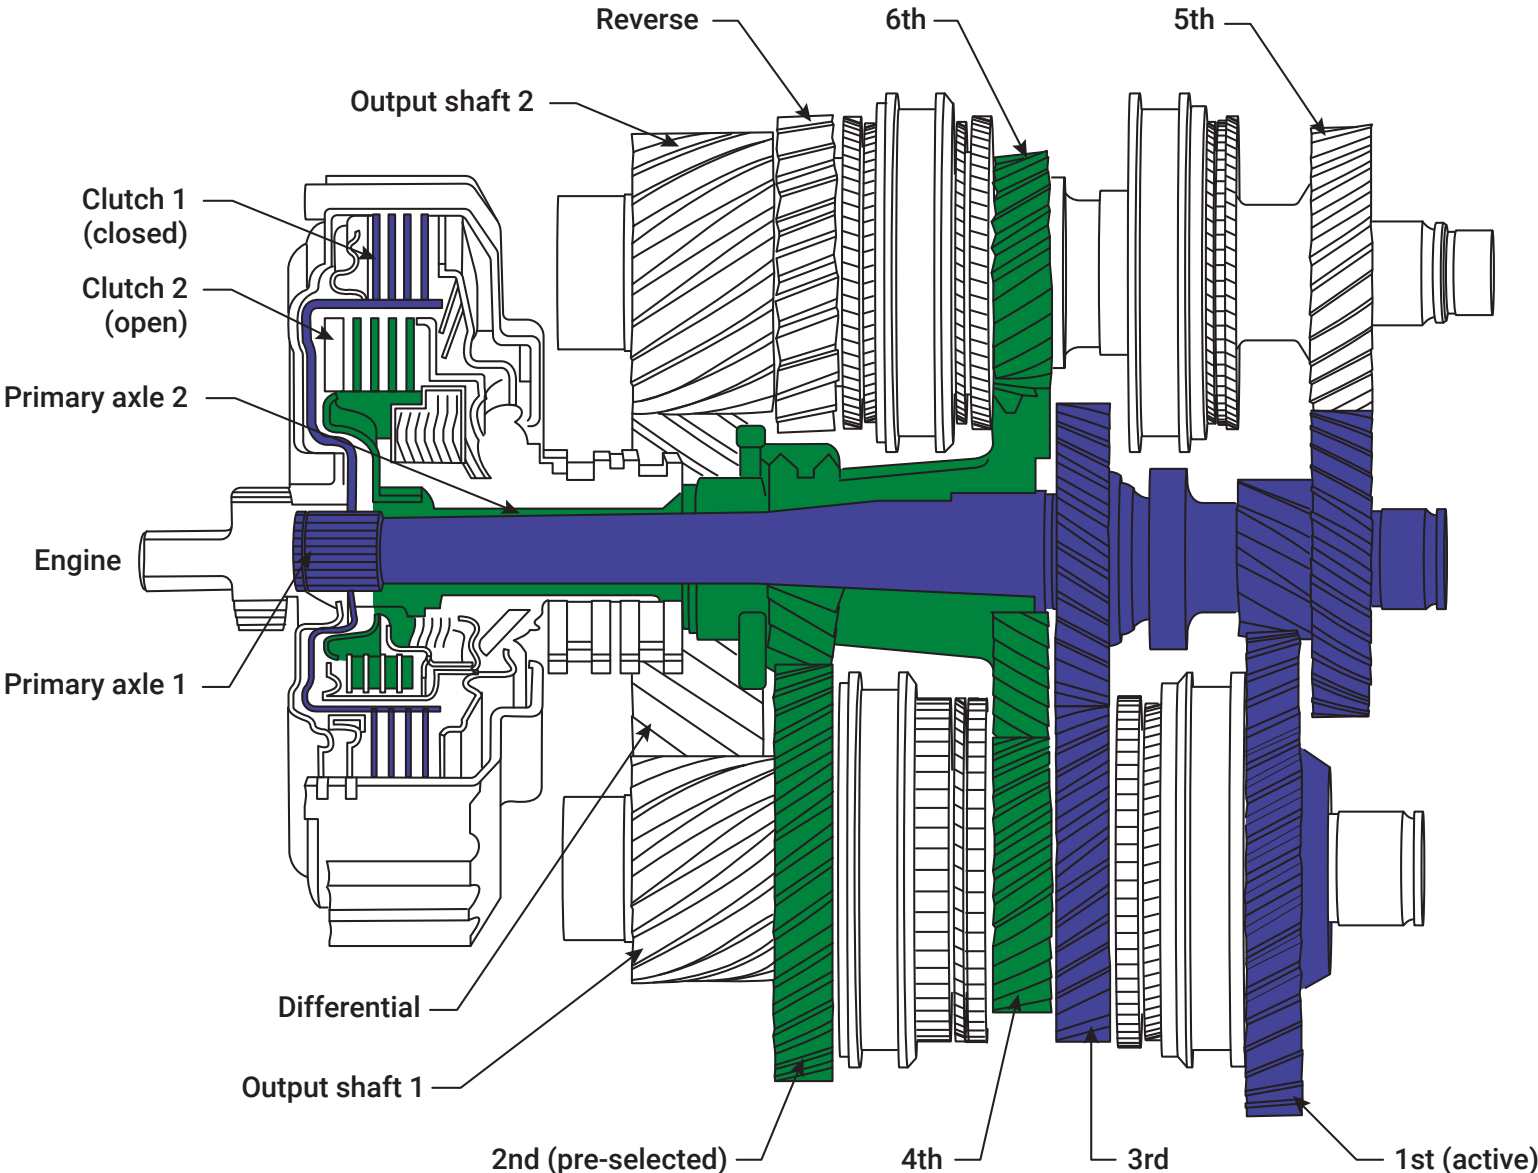
Schematics of a DSG 6 gearbox

Shifting, clutch activation and clutch de-activation are controlled from the central gearbox control unit, the Mechatronic (J743). This consists of an electronic control device and an electro-hydraulic control unit. The Mechatronic is built against the gearbox and forms part of the hydraulic circuit of the gearbox.

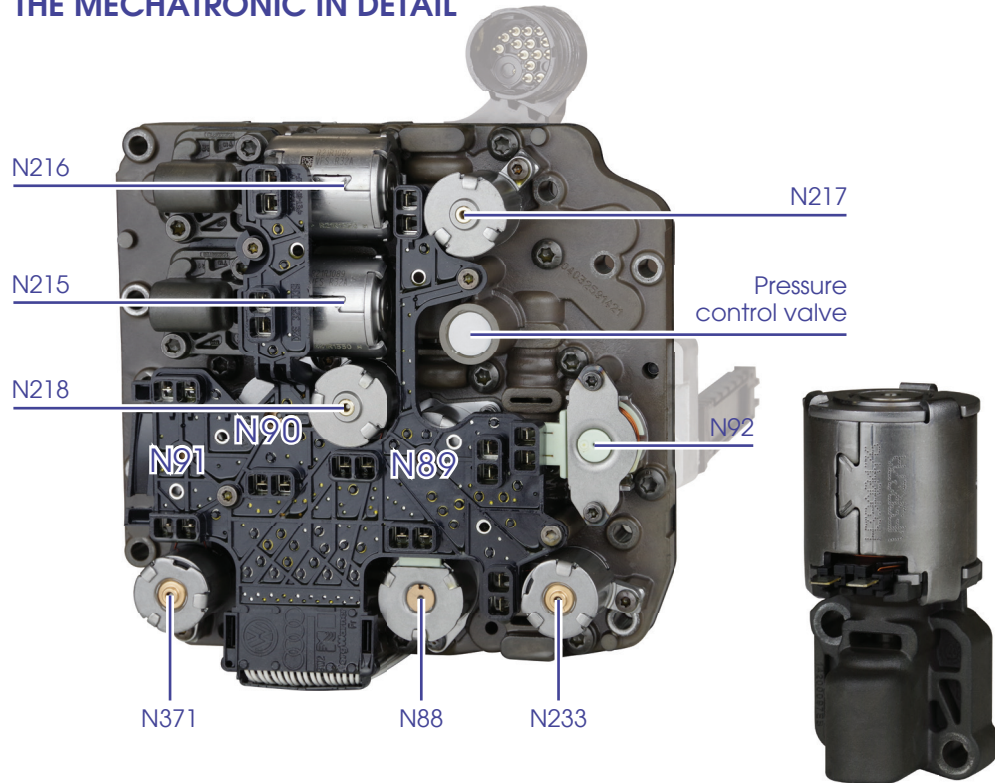
THE MECHATRONIC IN DETAIL

The Mechatronic has five shift (yes/no) valves and six control (modulation) valves. The five shift valves (N88, N89, N90, N91 and N92 (for the multiplexer, see hydraulic diagram) operate the shift forks that engage the gear wheels on the output shafts.

The six control valves regulate the various pressures required: the head pressure in the hydraulic system (N217), the pressure for the cooling oil in the multi-plate clutches (N218), the pressure at which the two multi-plate clutches are energised (pressed) (N215 and N216), and the pressure in the two safety valves which, in the event of a malfunction, are actuated in order to depressurise the respective gearbox part (N233 and N371).

Actuator	Function
N88	Shift valve for shifting 1st and 5th gears
N89	Shift valve for shifting 3rd gear and neutral
N90	Shift valve for shifting 2nd and 6th gears
N91	Shift valve for shifting 4th and reverse gear
N92	Switching valve for the multiplexer
N215	Pressure control valve for clutch K1
N216	Pressure control valve for clutch K2
N217	Main pressure control valve
N218	Pressure relief valve for the clutch cooling oil
N233	Safety valve for sub-gearbox 1
N371	Safety valve for sub-gearbox 2

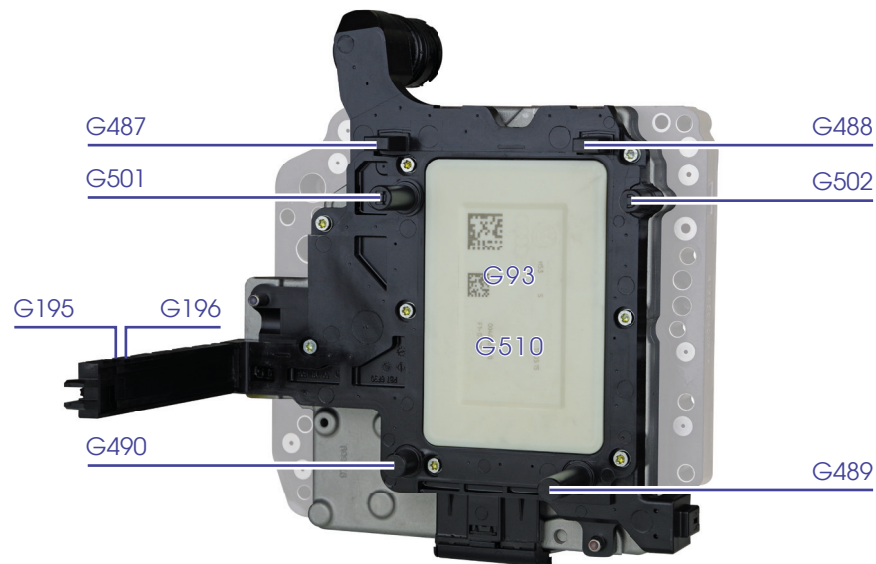
THE TCU IN DETAIL

Sensor	Function
G93	Gearbox oil temperature sensor
G182	Speed sensor input shaft gearbox
G193	Pressure sensor for hydraulic pressure of clutch K1
G194	Pressure sensor for the hydraulic pressure of clutch K2
G195	Speed sensor for the second gearbox output shaft
G196	Speed sensor for the second gearbox output shaft
G487	Position detection sensor for the selector fork for 1st and 3rd gears
G488	Position detection sensor for the selector fork for 2nd and 4th gears
G489	Position detection sensor for the selector fork for 6th and reverse gears
G490	Position detection sensor for the selector fork for 5th gear and neutral
G501	Speed sensor for drive shaft 1
G502	Speed sensor for drive shaft 2
G509	Gearbox oil temperature sensor at the multi-plate clutch
G510	Gearbox oil temperature sensor in the electronic control unit

In order to provide the Mechatronic with the necessary information, the TCU receives information from a number of sensors:

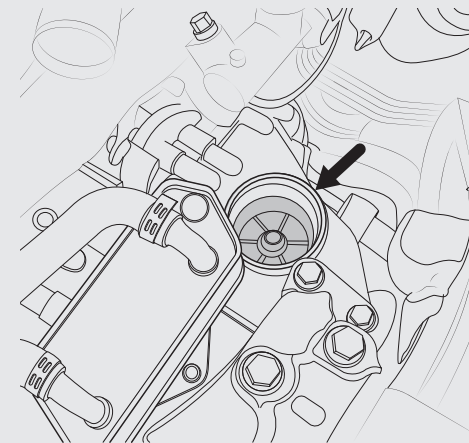
In order to be able to control the gearbox properly, it is important that the sensors, the shift valves and the control valves in the Mechatronic work properly. Because the oil in and with which these components work is also used to cool and/or lubricate the multi-plate clutches, gearbox gears, bearings and the synchronisation, it can become very contaminated.

If the contamination of the oil becomes so great that the gearbox oil filter becomes clogged, the oil will circulate through the bypass, which means that the oil will no longer be filtered. Wear and tear can then accumulate on the sensors and in the shift and control valves, causing the Mechatronic to malfunction and adversely affecting the operation of the gearbox. It is therefore important that the oil and filter of the DSG 6 gearbox are changed every 60,000 km.
