DIAGNOSIS GUIDE

TRANSMISSION CONTROL UNIT

**ALL RELEVANT INFORMATION
IN ONE GUIDE**

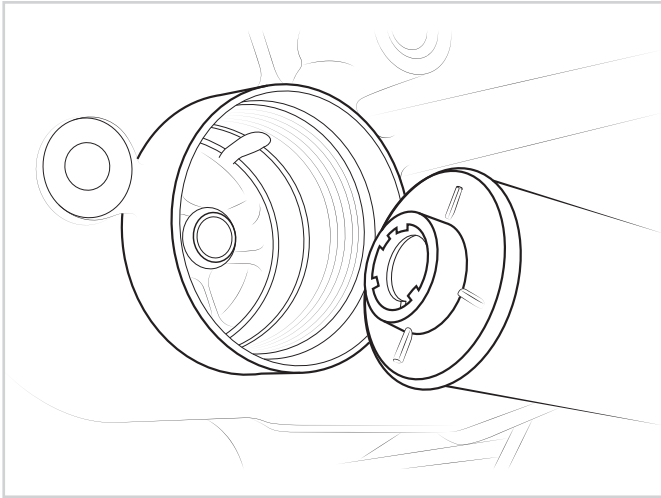
1. Remove all parts that prevent the oil filter from being undone. Think for example of the engine cover and the air filter housing.
2. Rotate the gearbox oil filter housing (1).
3. Keep the oil filter housing slightly tilted before removing it. This will allow the oil remaining in the oil filter to drain out of the filter into the gearbox.
4. Now remove the oil filter (3).
5. O-ring (2) must be replaced. Lubricate the **new** O-ring with DSG oil.
6. Also lubricate the small O-ring at the bottom of the filter with DSG oil

7. Fit the **new** oil filter and the **new** large O-ring and tighten the oil filter housing to a torque of 20 Nm.
8. Reassemble all previously removed parts.

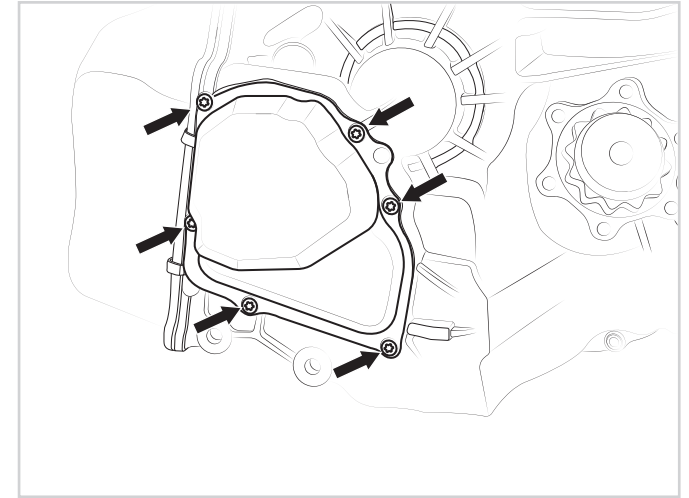
1. Unscrew oil drain plug B at the pendulum support and then disassemble the overflow pipe fitted in the hole with an 8 mm Allen key. About 5 litres of oil will now be released from the gearbox.
2. When the gearbox is empty, install the overflow pipe again with a tightening torque of 3 Nm.

3. Loosen the bolts of the oil pump cover (on the side of the gearbox) crosswise and remove the cover.

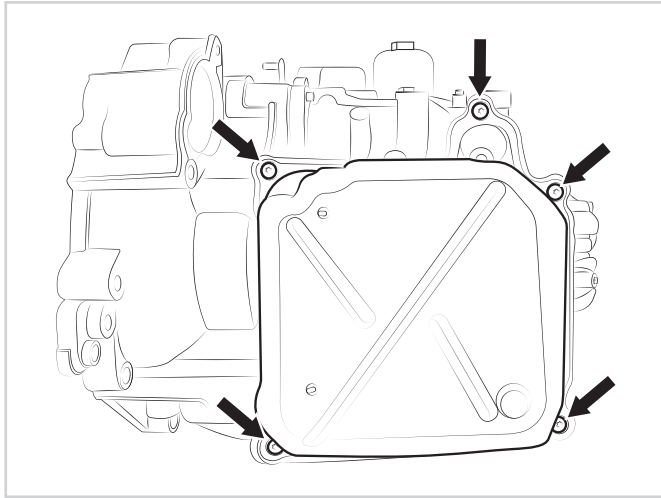
4. Loosen the oil sump screws crosswise. These bolts must be **renewed**.
5. Remove the oil sump with the gasket. The gasket must be **renewed**.
6. Make sure that no dirt gets into the Mechatronic.

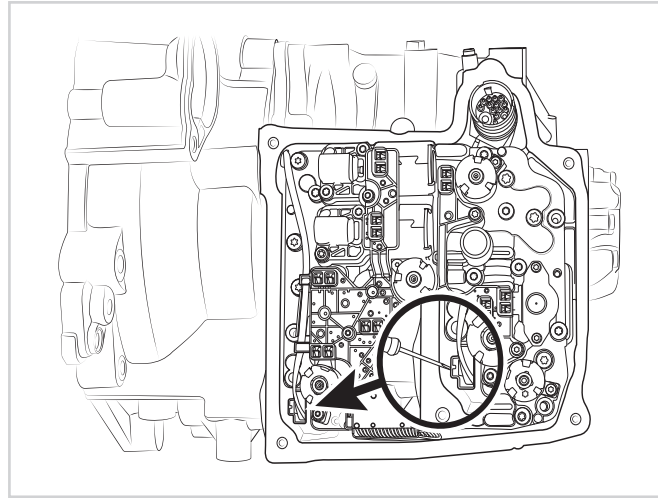
1. Carefully unplug input speed sensor G182 and oil temperature sensor G509. Use two flathead screwdrivers: one to unlock and one to separate the connector from the socket. Do not pull on the wiring! When the plug is disconnected, disconnect the wiring from the terminals (see arrows).

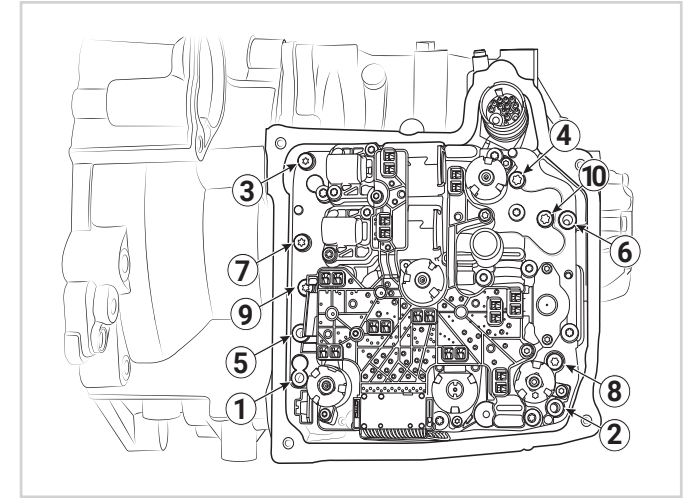
2. Remove the screws from the Mechatronic in the order indicated.

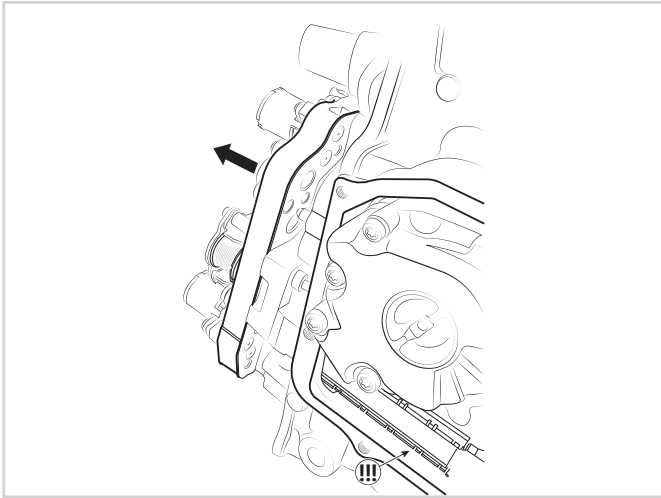
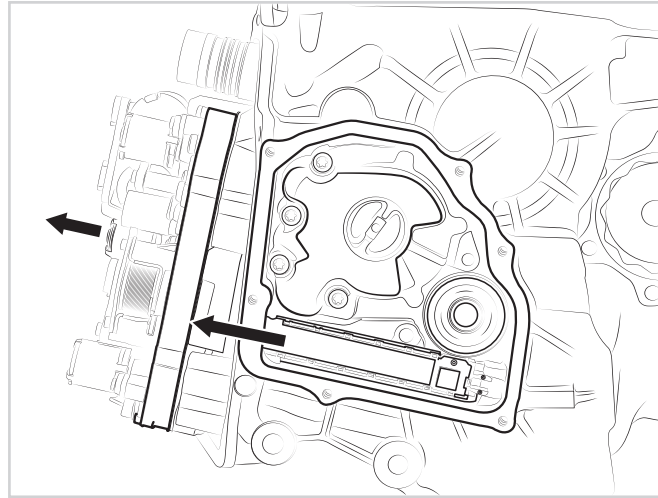
3. Carefully remove the Mechatronic from the gearbox housing and pay attention to the long sensor arm (see !!!) under the oil pump. This is very vulnerable.
4. When the sensor arm of the Mechatronic has been completely pushed out of the gearbox housing, the Mechatronic can be removed with a rotating movement downwards. Make sure that the long sensor arm is not loaded.
5. Carefully lay the Mechatronic down with the long sensor arm up. Never lift the Mechatronic by the sensor arm because it breaks easily.

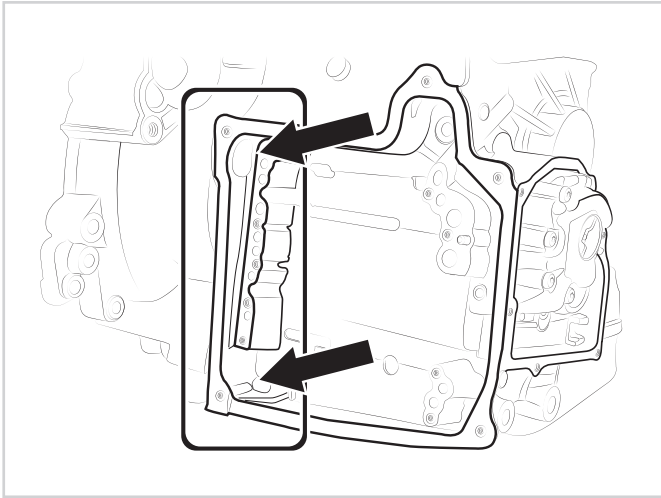
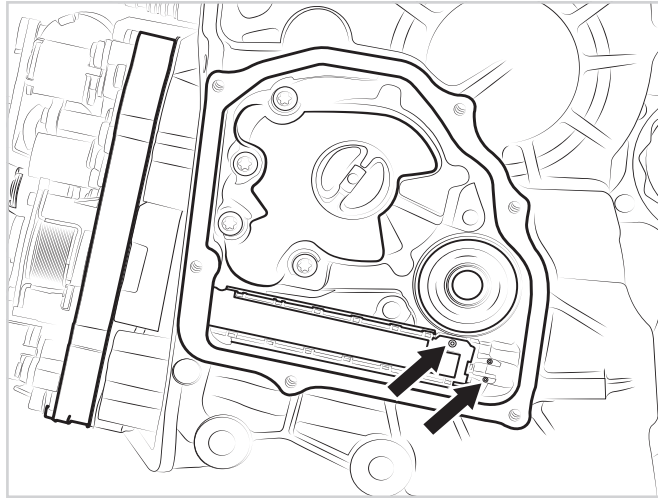
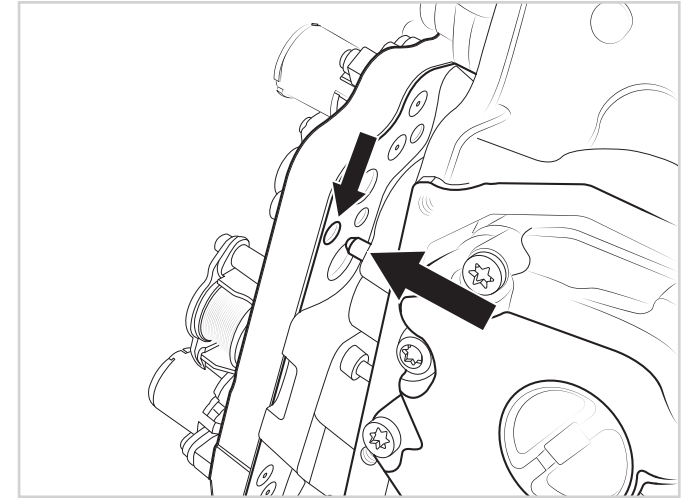
INSTALLING THE MECHATRONIC AFTER REMANUFACTURING

1. First check whether the speed sensor G182 and the oil temperature sensor G509 are installed.
2. Carefully insert the Mechatronic into the gearbox housing. Pay close attention to the long sensor arm: it must be correctly positioned in the seat of the gearbox housing
3. Check that the alignment pin is properly positioned in the recess.

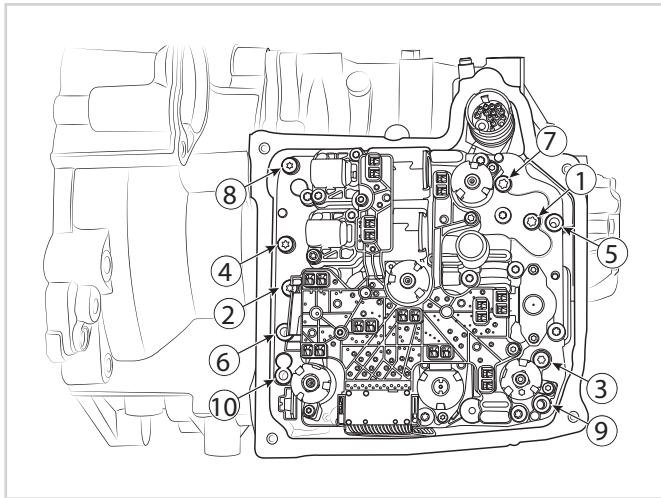
4. Mount the bolts of the Mechatronic hand-tight.
5. Now tighten the bolts in the specified order
Tightening torque: 5 Nm + 90°
6. Secure the wiring for the G182 and G509 sensors with clamps: first the upper clamp, then the lower clamp.
7. Mount the plug of sensors G182 and G509.

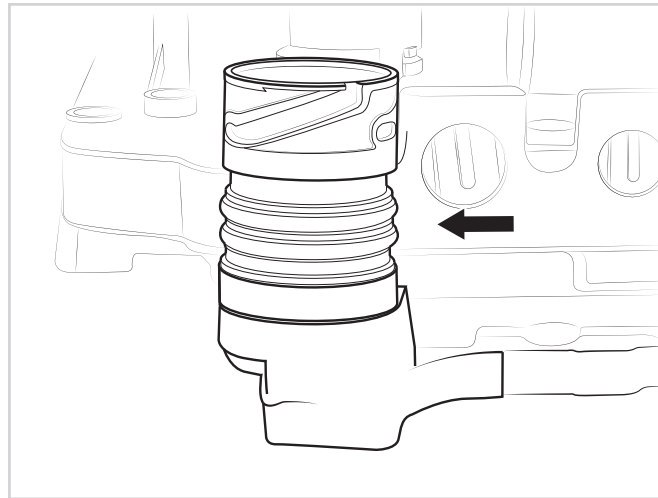
8. Replace both O-rings on the Mechatronic connector: clear the sealing surfaces of the connector of old oil and dirt and lubricate the **new** O-rings with DSG oil.

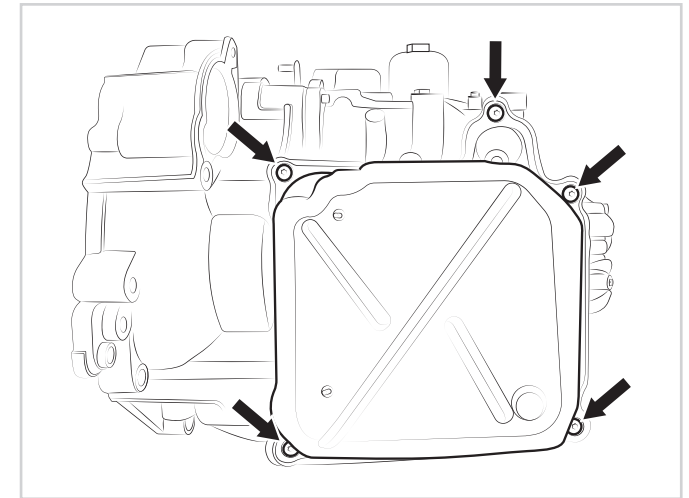
9. Insert the oil sump with **new** gasket. Make sure no wiring is pinched.
10. Install the **new** bolts and tighten them crosswise.
Tightening torque: 10 Nm.

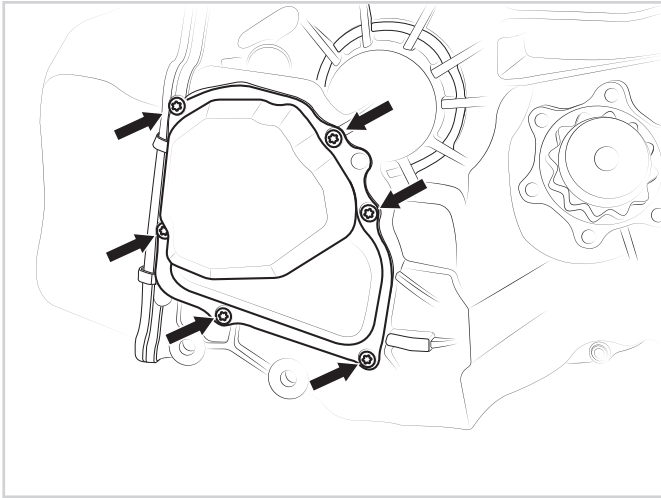
11. Fit the oil pump cover and fit the bolts.
12. Tighten the bolts crosswise in several steps. Tightening torque: 8 Nm.
13. Mount the wire guide bracket and tighten the two M6 nuts to 10 Nm.
14. Place the round connector on the Mechatronic plug and tighten the bayonet fitting clockwise.
15. If applicable, install the connecting hose between the intercooler and the intercooler tube.
16. Connect the battery ground cable, but do not start the engine yet!

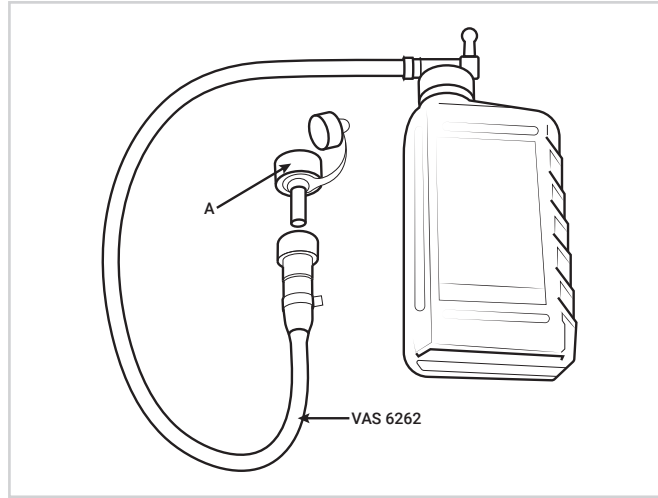
1. Check that the overflow pipe is present in the hole of the drain plug.
2. Mount adapter "A" of VAS 6262 hand-tight in the drain opening.
3. Fill the gearbox with at least 5.5 litres of DSG oil via adapter "A" of VAS 6262: shake the DSG oil bottles before opening them.
4. Read the gearbox oil temperature using the factory scan tool (VAG-COM or VAS 5051).
5. Start the engine, hold down the brake pedal and select each selector lever position for about 3 seconds.
6. Return the selector lever to "P" and let the engine run.

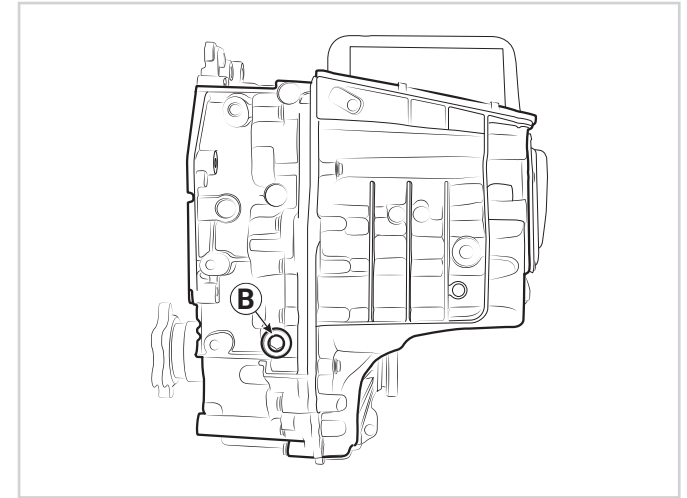
7. Disassemble (with engine running and gearbox temperature 35°C to 45°C) adapter "A" from VAS 6262.
 8. Excess oil will now flow over the overflow pipe. If this is not the case, oil must be added. Wait until the overflow turns to a drip. The gearbox is now full.
9. Install the drain plug with a **new** sealing ring. Tightening torque: 45 Nm.
10. Now turn off the engine.
11. If applicable, install the soundproofing panel under the gearbox.

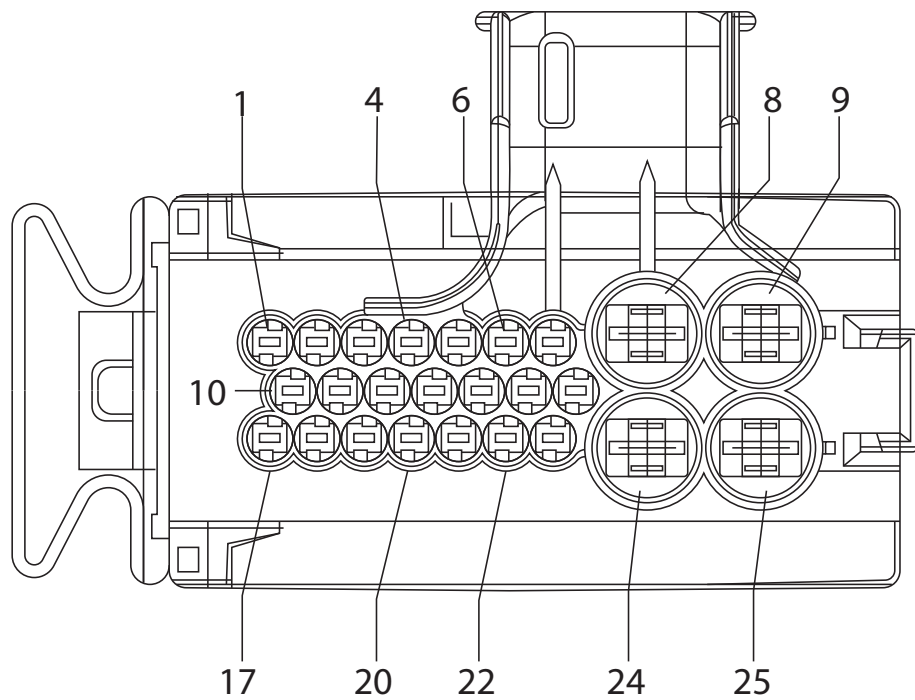
Connector on harness side.

Pin 8	Ground 31
Pin 9	Power supply 12V 30+ (30A)
Pin 10	Power supply 12V 15+ (10A)
Pin 11	K-line
Pin 12	CAN low
Pin 13	CAN high
Pin 16	P/N signal (start control)
Pin 24	Ground 31
Pin 25	Power supply 12V 30+ (15A)

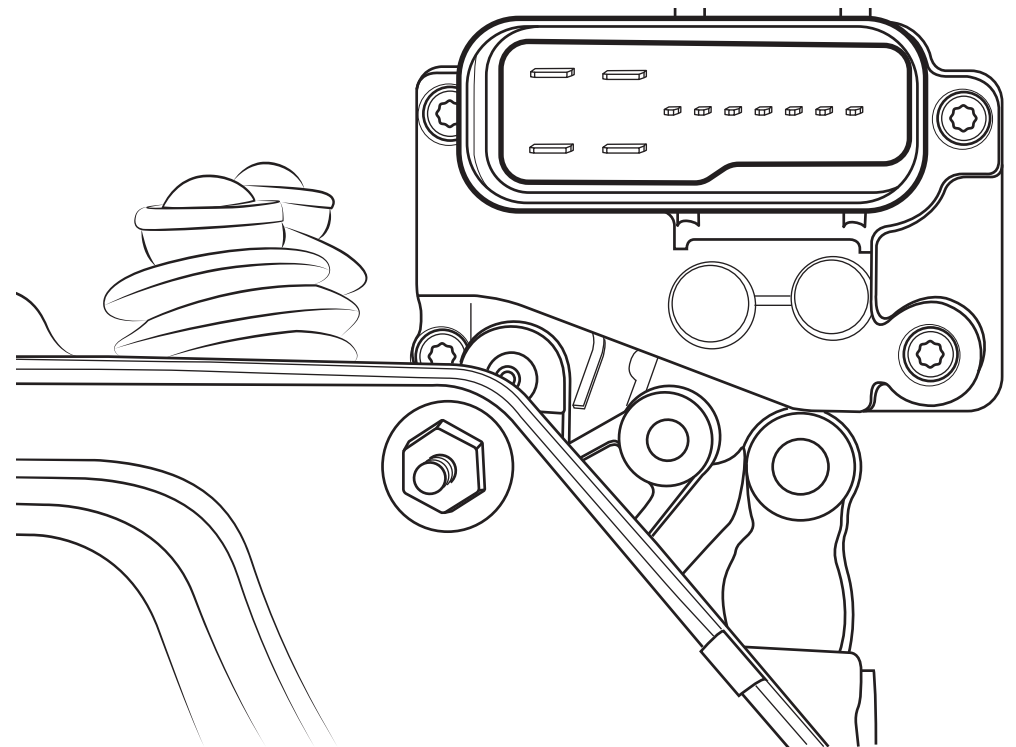
Connector on DSG 7 side.

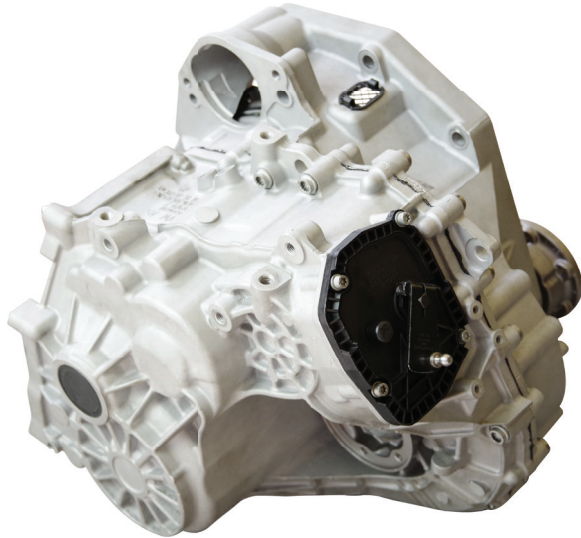
GENERAL OPERATION

The DSG 7 gearbox is an automatic double clutch gearbox. DSG stands for "Direktschaltgetriebe" or "Direct Shift Gearbox" and the 7 indicates that there are seven forward gears. For this gearbox the designation 'DQ200' is also used. The Q ('Quermotor') indicates that this gearbox is used for transverse engines.

Mechanically, the DSG 7 gearbox can be described as a manual gearbox with two dry plate clutches, two drive shafts (input, primary) and three output shafts (secondary).

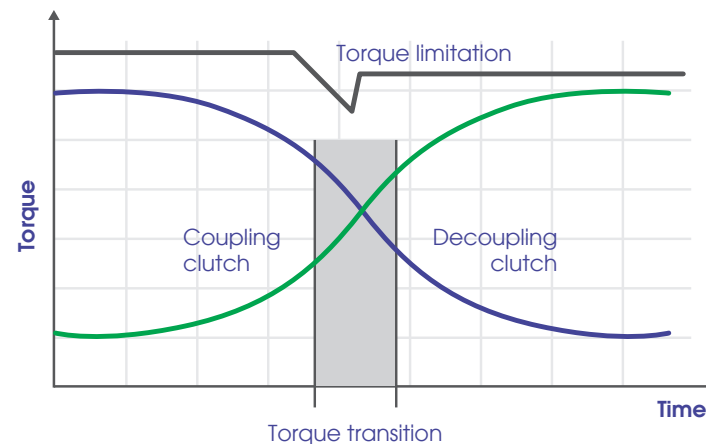
Because the gears for 1st, 3rd, 5th and 7th gear are on **drive shaft 1** and the gears for 2nd, 4th, 6th gear on **drive shaft 2**, shifting takes place from one drive axle to the other when shifting to the next gear.

The next gear is already engaged on the corresponding output (main) shaft. When shifting gears, the clutch to the drive shaft of the 'old' gear is decoupled in one smooth movement and the clutch to the drive shaft of the 'new' gear is coupled in one smooth movement. So there is an overlap in the drive through both gears. In addition, when shifting up, the engine torque is slightly lowered, while when shifting down, the engine torque is slightly increased. All in all, this ensures a fast and smooth shifting action with no noticeable interruption in propulsion.

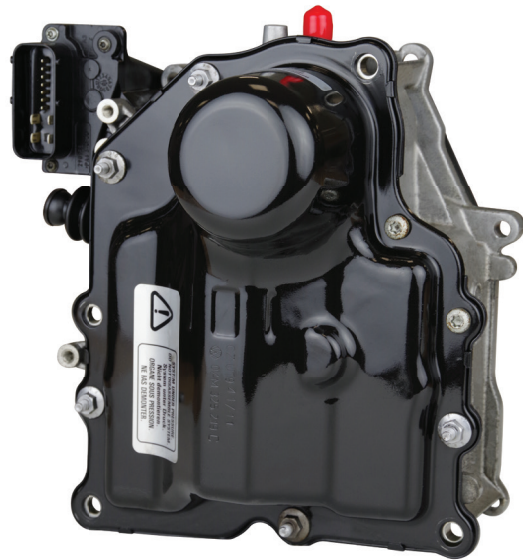
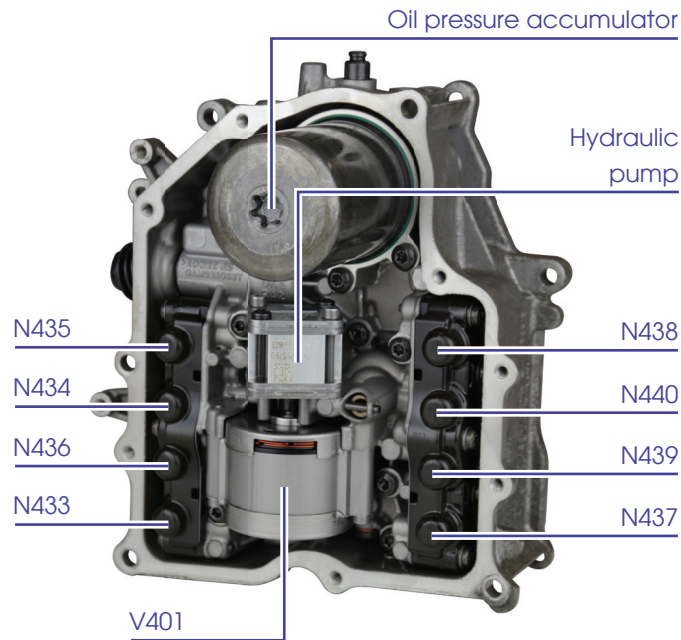
THE MECHATRONIC IN DETAIL

system pressure in the control unit remains between 40 and 60 bar.

The electro-hydraulic control unit has eight control valves. Valves N433, N434, N437 and N438 operate the shift forks that engage the gearwheels on the output shafts. Control valves N435 and N439 operate both clutches. Valves N436 and N440 regulate the required system pressures in both gearbox halves:

The electro-hydraulic control unit incorporates an electrically driven V401 hydraulic pump and an oil pressure accumulator, which together ensure that the

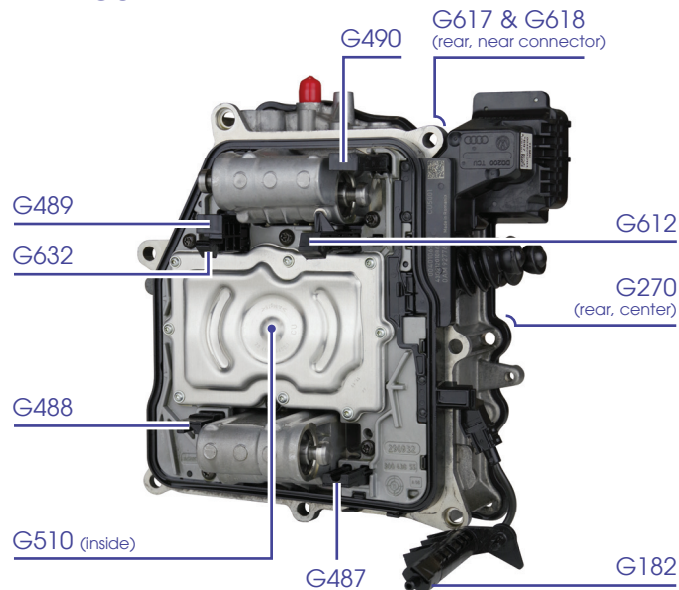
THE TCU IN DETAIL

Sensor	Function
G182	Speed sensor input shaft gearbox
G270	Pressure sensor for the hydraulic pressure of the gearbox
G487	Position detection sensor for the selector fork for 2nd and 4th gears
G488	Position detection sensor for the selector fork for 1st and 3rd gears
G489	Position recognition sensor for the shifting fork for 5th and 7th gears
G490	Position detection sensor for the selector fork for 6th and reverse gears
G510	Gearbox oil temperature sensor in the electronic control unit
G612	Speed sensor for drive shaft 2
G617	Clutch path sensor for clutch K1
G618	Clutch path sensor for clutch K2
G632	Speed sensor for drive shaft 1

Always check the three speed sensors for metal particles. If there is any contamination, check the gearbox thoroughly for mechanical wear/damage. Then clean the sensor

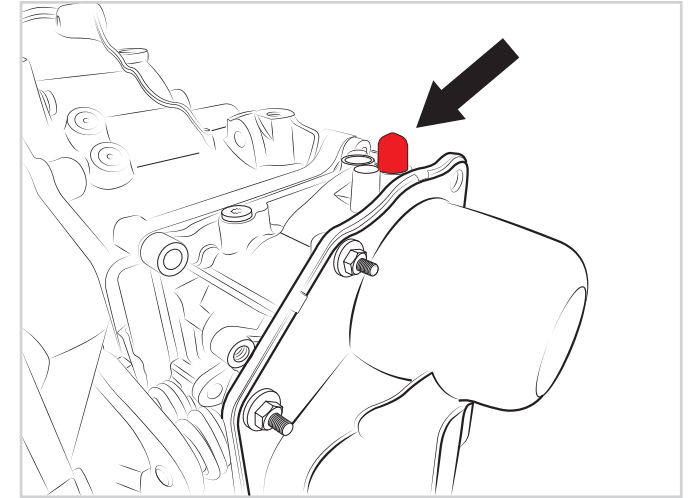
Sealing the Mechatronic

1. Now remove the breather plug (see figure) and seal the opening **oil-tight**.

The above step is very important, because the oil level in the Mechatronic cannot be checked and therefore cannot be topped up correctly. No hydraulic oil should leak out of the Mechatronic at all, not even after disassembly!

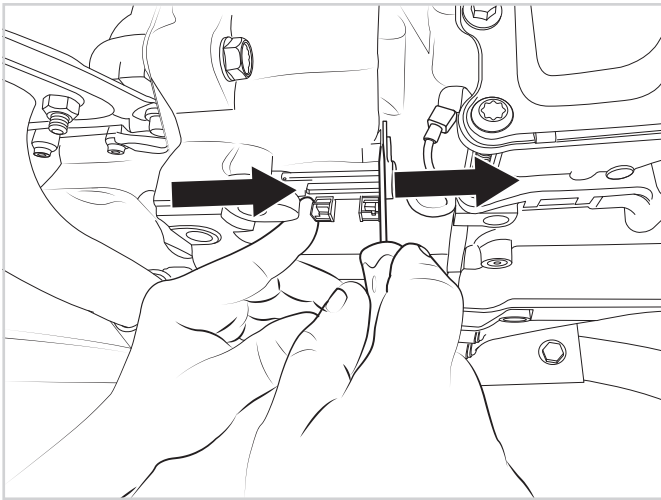
Releasing the control arms from the tappets

1. Carefully push the speed sensor out of the housing with a screwdriver.

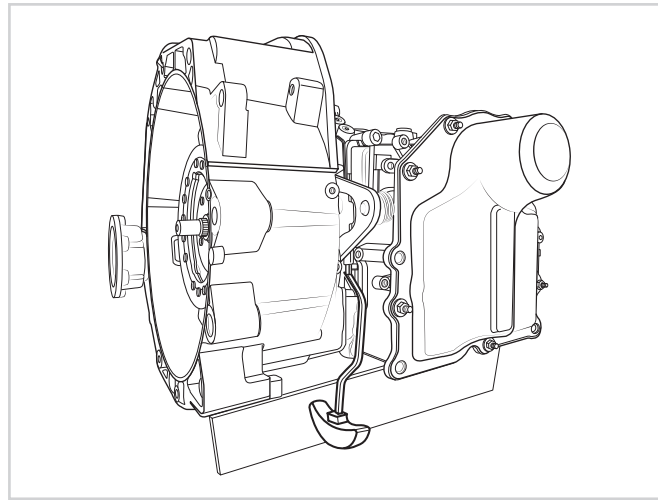
2. Insert the mounting lever T10407 (original Volkswagen AG tool) to the right of the control arms.
 3. Slide the mounting lever all the way through until the rear end is against the gearbox housing: the groove of the mounting lever must be in a straight line with the edge of the housing.

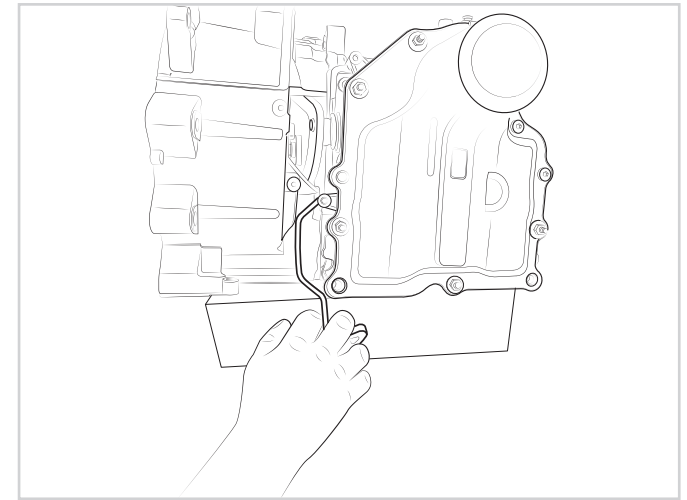
4. Now slowly turn the mounting lever anticlockwise to release the control arms from the tappets.

Then leave the mounting lever in exactly the same place. Removing it may have a negative effect on the clutch adjustment mechanism.

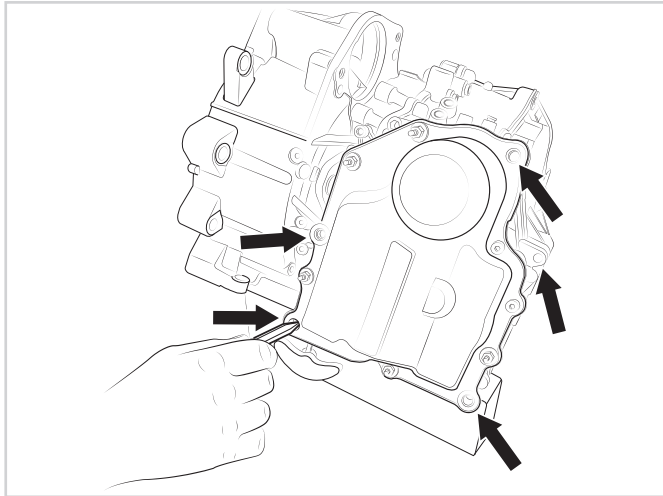
Removing the Mechatronic

1. Remove only the 7 bolts that hold the Mechatronic in place, see arrows in the illustration: 4x long, 3x short, Torx 45.
2. Remove the Mechatronic from the gearbox in a straight line and keep it upright so that no oil can escape from the Mechatronic.

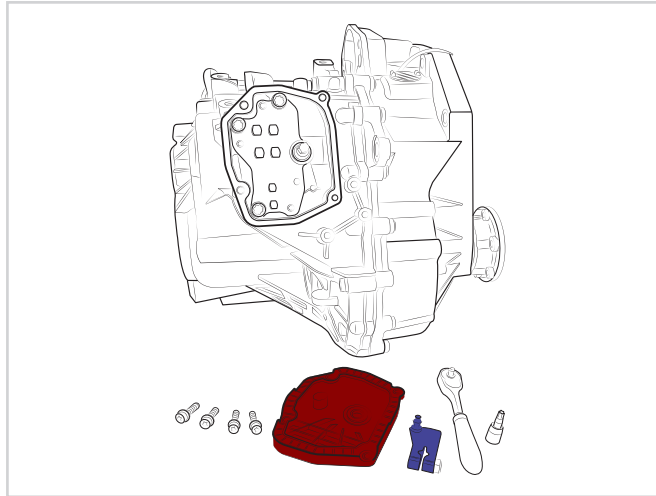
Set the gearshift mechanisms to "neutral"

If the mechatronic is stuck and cannot be removed, secure it again with a bolt and follow the next steps:

1. Disconnect the shift cable from the gearbox.
2. Remove the shift fork (purple).
3. Remove the cover (red).
4. Now push the selector fork (purple) aside by hand.
5. It is now possible to remove the Mechatronic.

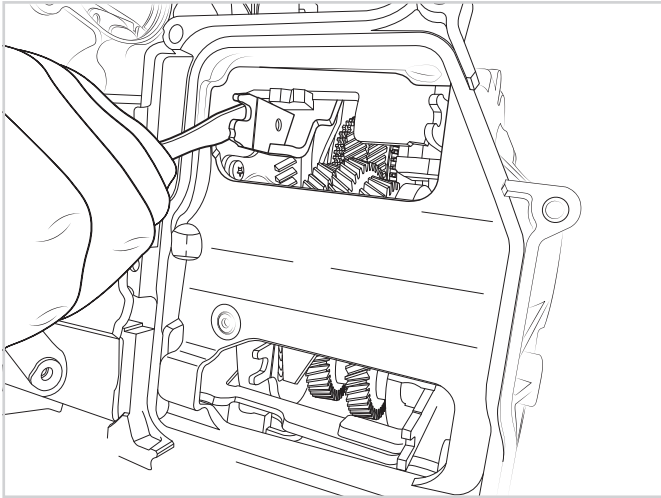
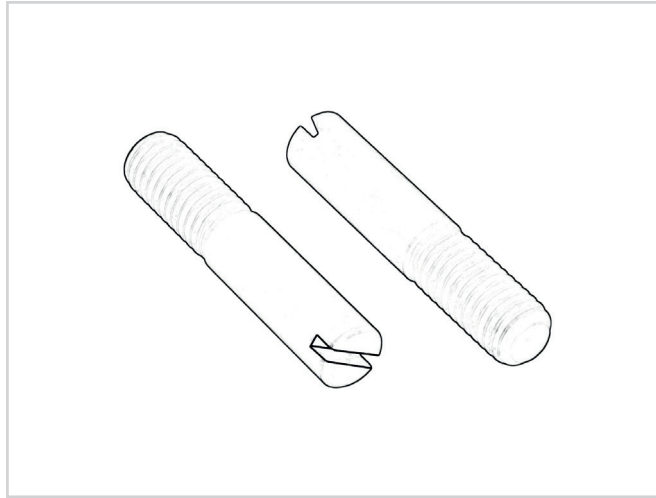
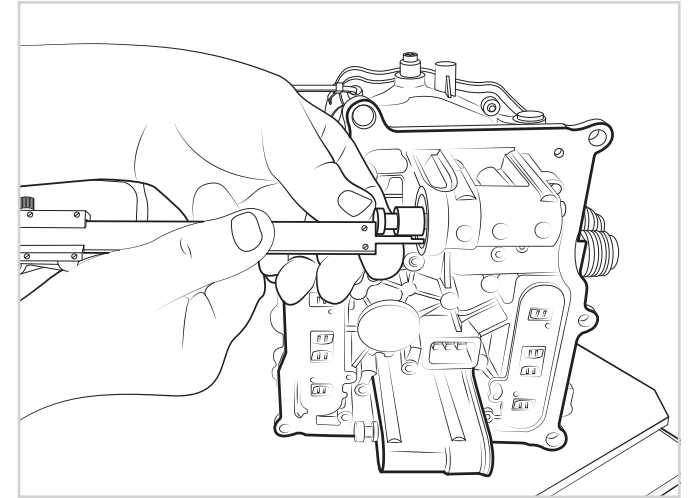
Prior to assembly

1. Check that all shift forks (4x) are still in neutral position. Each fork has 3 positions: gear, neutral, gear. All forks must therefore be in the middle position.
2. Insert 2x guide bolt T10406 (original Volkswagen AG tool).
3. Check that the 4 tappets of the Mechatronic all protrude by 25 mm, see dimension "a" in the illustration.
4. Check that the seal of the Mechatronic is undamaged and leak-proof.

If the Mechatronic is remanufactured by us, we always send a tool (in the form of a black bushing) to help with point 3. This tool can be slid over the tappet. The tool will then always depress the tappet to the correct length.

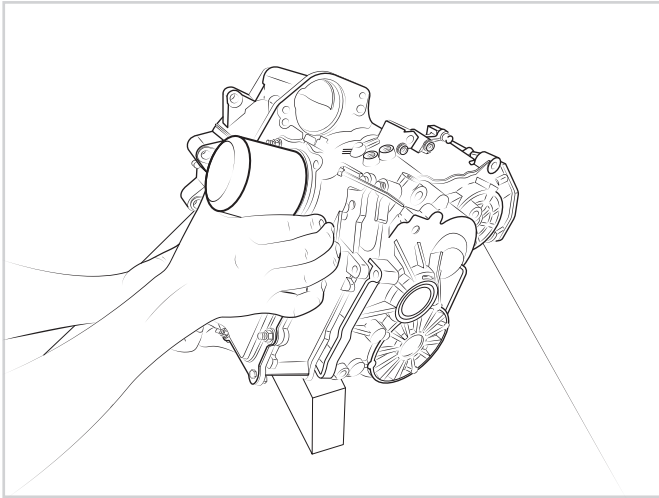
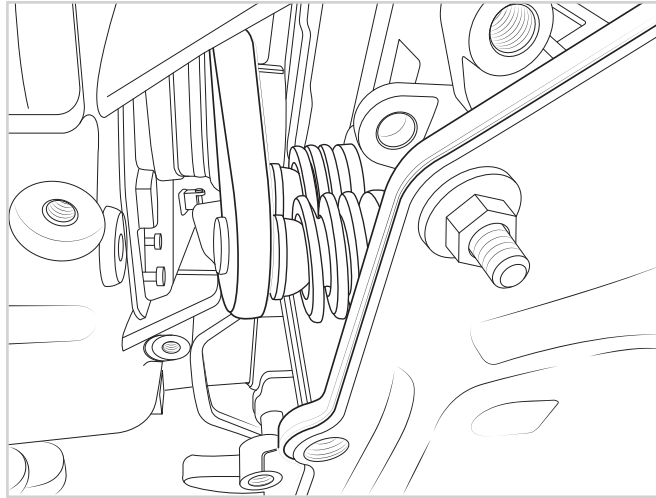
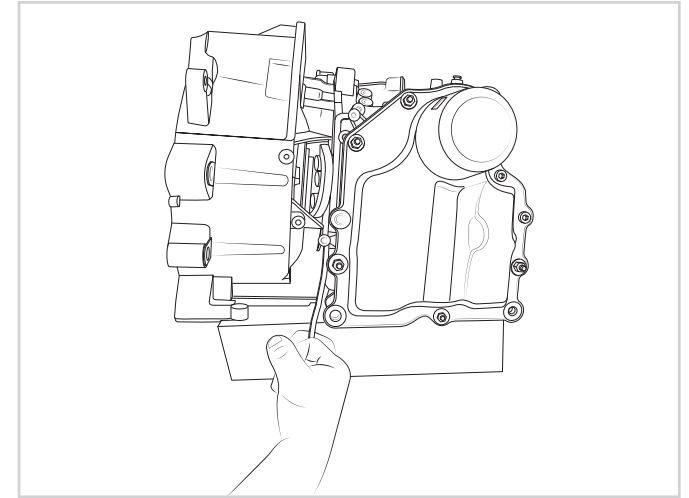
Mounting the Mechatronic

1. Place the Mechatronic gently over the guide bolts into the correct position.
2. Tighten the Mechatronic by **hand-tightening** the 7 bolts.
3. Remove the guide bolts.
4. Check the position of the clutch cylinders in relation to the clutch levers. Incorrectly attached clutch cylinders can damage the Mechatronic.
5. Tighten the 7 fixing bolts crosswise. Tightening torque: 10 Nm.
6. Turn the mounting lever clockwise and remove it from the shift mechanism.

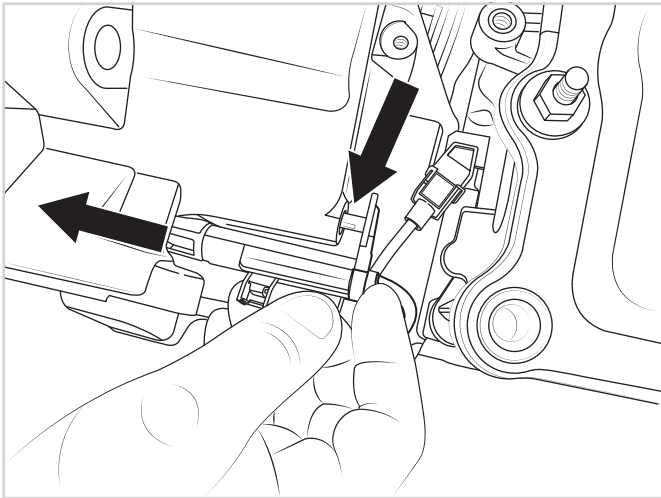
7. Put the speed sensor back in position. The clip must not be broken and the sensor must be completely attached to the housing as shown by the arrows in the illustration.

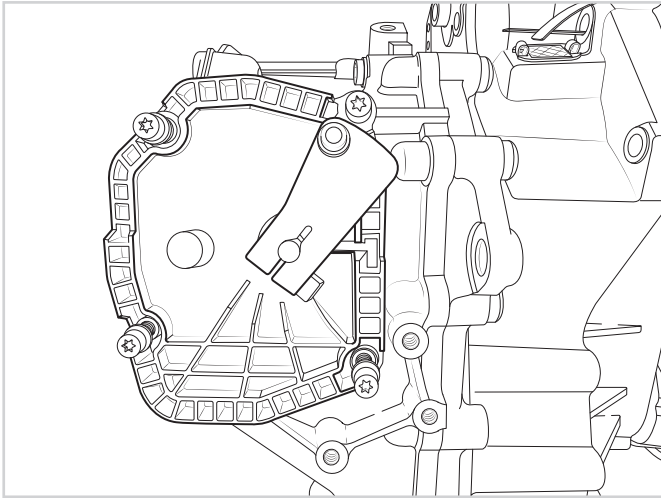
Filling with gearbox oil

1. First follow the steps of "Setting the gearshift mechanisms to "neutral"" in "Removing the Mechatronic".
2. Pour exactly 1.9 litres of the prescribed gearbox oil into the opening by the fork.
3. Also apply some oil to the O-ring before replacing the cover plate.

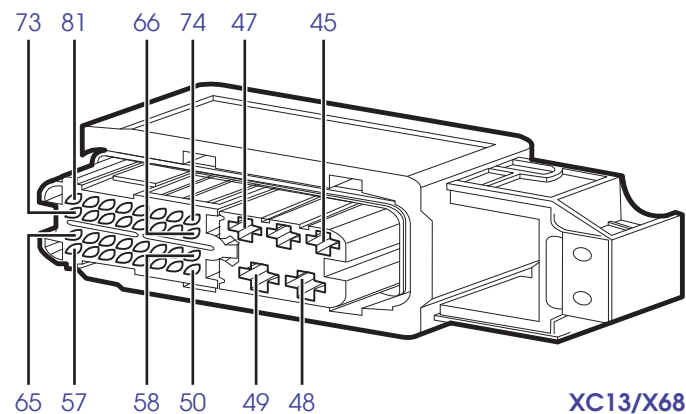
Pin 45	K-line
Pin 47	Power supply 12V +15
Pin 48	Ground 31
Pin 49	Power supply 12V +30
Pin 52	Brake light switch
Pin 54	CAN high
Pin 56	CAN low
Pin 57	Complement from pin 74 (interspersed with ecu check pulses)
Pin 61	Link CAN high
Pin 63	Link CAN low
Pin 74	Manual position = pulse train to 12V Auto position = pulse train to 10V
Pin 76	Data burst signal
Pin 77	Clock burst signal

The pin numbers in **bold** refer to the selector lever, which can be used to change gears manually if necessary. See also the wiring diagram for both types (2-wire or 4-wire)

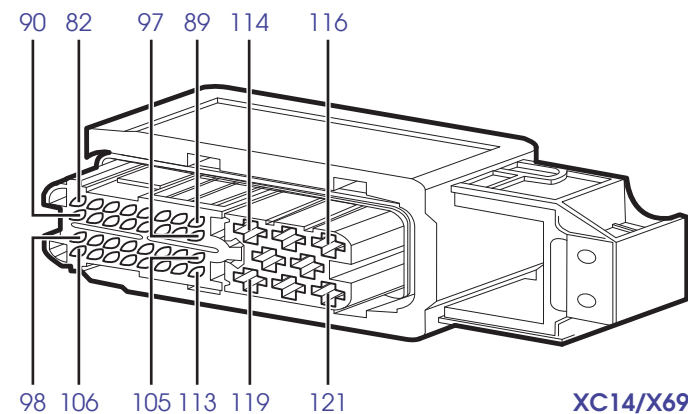
PIN ASSIGNMENT FOR TCU CONNECTOR 2 (XC14/X69)

Pin 106	Sensor input 2 (counter)
Pin 107	Sensor input 1 (direction)
Pin 108	Sensor input 2 (counter)
Pin 109	Sensor input 1 (direction)
Pin 114	Engine ground
Pin 115	Engine ground
Pin 116	Power supply 12V motor
Pin 117	Power supply 12V motor
Pin 118	Power supply 12V sensor
Pin 119	Power supply 12V sensor
Pin 120	Ground sensor
Pin 121	Ground sensor

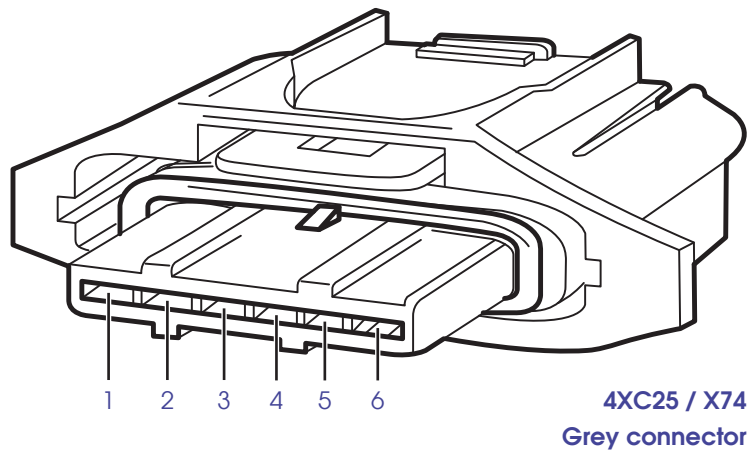
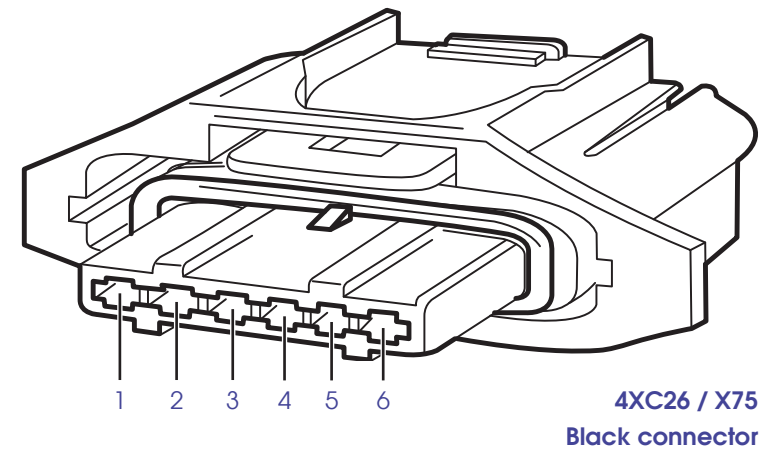
PIN ASSIGNMENT FOR THE CONNECTORS OF THE SHIFT MOTORS (XC25/X74 AND XC26/X75)

Pin 1	Power supply 12V motor
Pin 2	Ground sensor
Pin 3	Power supply 12V sensor
Pin 4	Sensor output 1 (direction)
Pin 5	Sensor output 2 (counter)
Pin 6	Engine ground

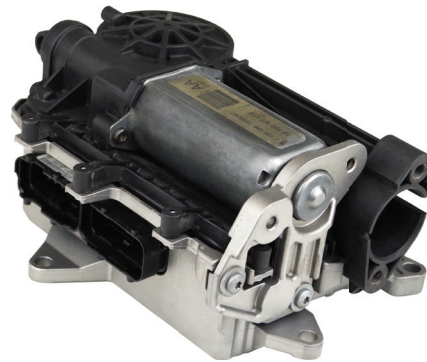
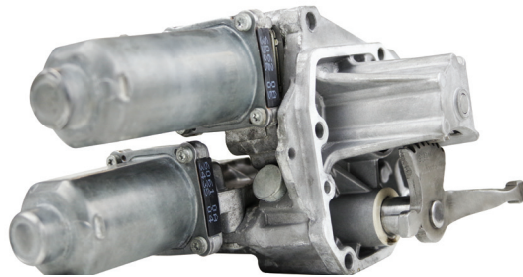
Easytronic is the name of the mechatronics that control the clutch and the gear selector. The component consists of a TCU, a clutch actuator and an electric motor.

The most vulnerable part of the Easytronic is the clutch actuator. It is mounted in a plastic housing and can quickly start leaking. If you suspect that the clutch actuator is leaking, carry out the official bleeding procedure at all times (see later in this document). The clutch actuator will certainly leak if it is defective.

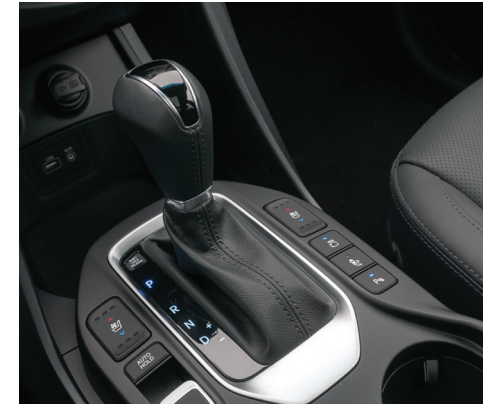
The gear selector lever occasionally causes strange malfunctions. The mechanism is not entirely mechanical, as in a normal manual gearbox: the selector lever operates the gears by sending an electrical signal (so no CAN message!) to the TCU in the Easytronic. It is therefore more like a joystick. The signal sent depends on the position in which the selector lever is set. It often fails as soon as the contact points become worn out: the correct signal is no longer sent to the TCU.

Want to check if the signal is still being sent? Under "Pin assignment", you can see which pins in the TCU connector are intended for the gear selector lever. For example, the signal at pin 76 should change when the selector lever is moved from "N" to "R".

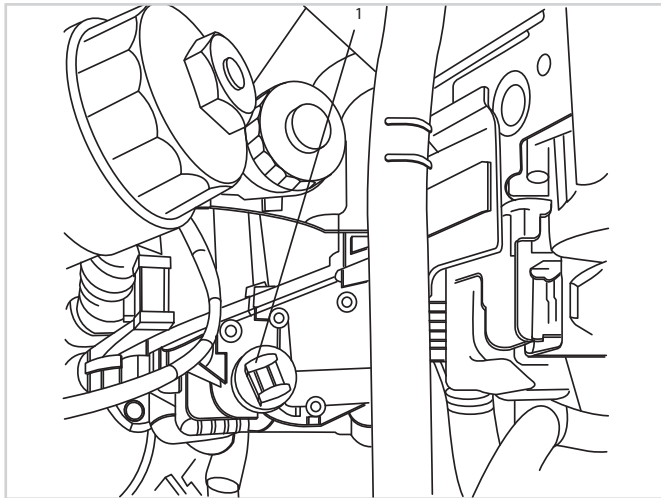
DISENGAGING A STUCK GEARBOX

If the gearbox cannot be set to "N" – e.g. due to a malfunction or a flat battery – the clutch can be disengaged with an emergency control. To do so, follow these steps:

1. Turn off the engine and apply the parking brake.
2. Clean the area around the sealing cap "1" **thoroughly**.
3. Turn the sealing cap "1" and pull it upwards.

4. Turn the adjustment screw "2" clockwise (to the right) until resistance is felt. Do not turn any further, as this may damage the Easytronic.

1. Turn the adjustment screw "2" anticlockwise (to the left) until resistance is felt.
2. Install a **new** sealing cap "1".
3. Turn on the ignition and wait at least 5 seconds. The clutch will adjust itself during this time.

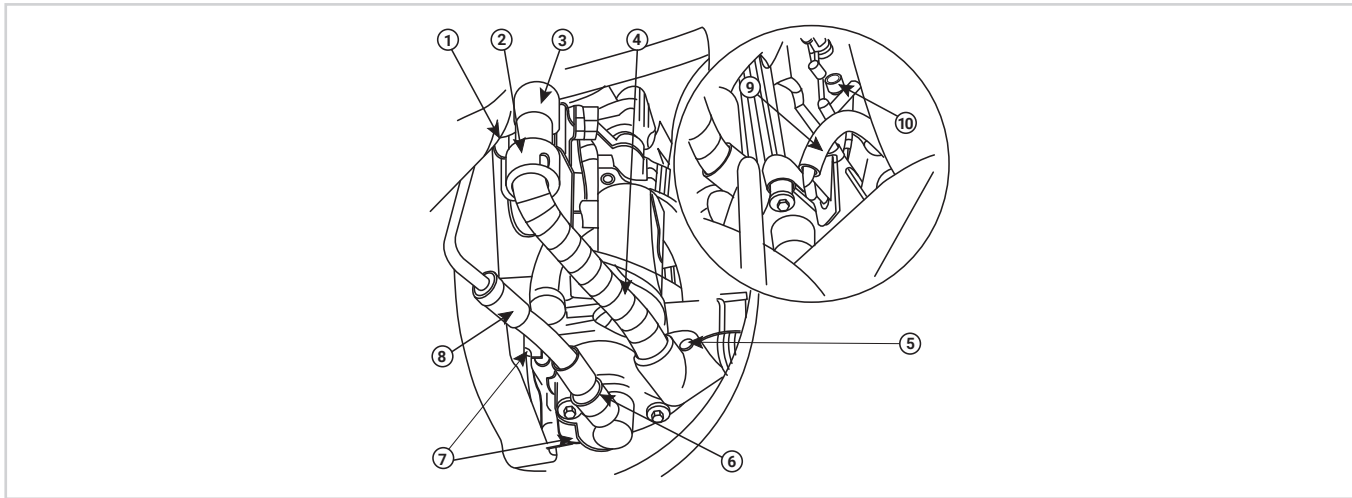
The Easytronic

1. Remove the cover of the hydraulic fluid reservoir.
2. Unlock and remove the wiring harness plug "3" from the Easytronic.
3. Remove the lower engine panelling (if applicable).
4. Disconnect the wiring harness holders "4" and "5". Unlock and remove the wiring harness plug "2" from the TCU.
5. Disconnect the brake fluid supply hose "9" and collect the escaping brake fluid.
6. Disconnect the clutch pressure line "8" by releasing the clamp "6" and collect the escaping brake fluid.
7. Remove the clutch actuator and the TCU together by loosening the clutch actuator screws "1", "7" and "10".

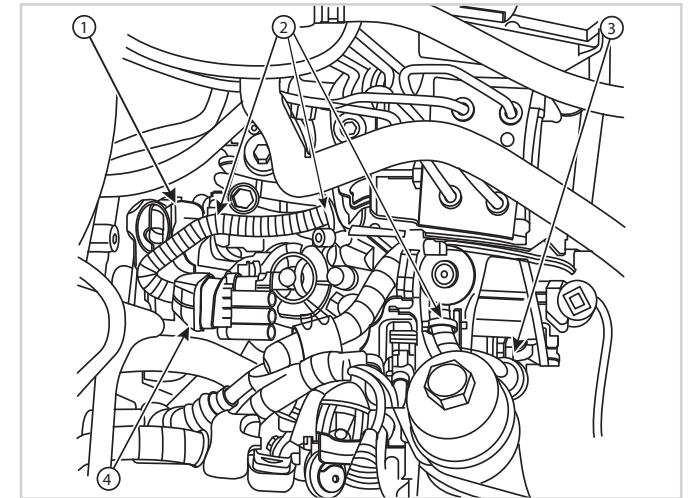
The wiring harness

1. Unlock and remove the wiring harness plug "3" from the Easytronic.
2. Unlock and remove the wiring harness plugs "1" and "4" from the shift module.
3. Loosen the cable tie "2".
4. Remove the wiring harness.

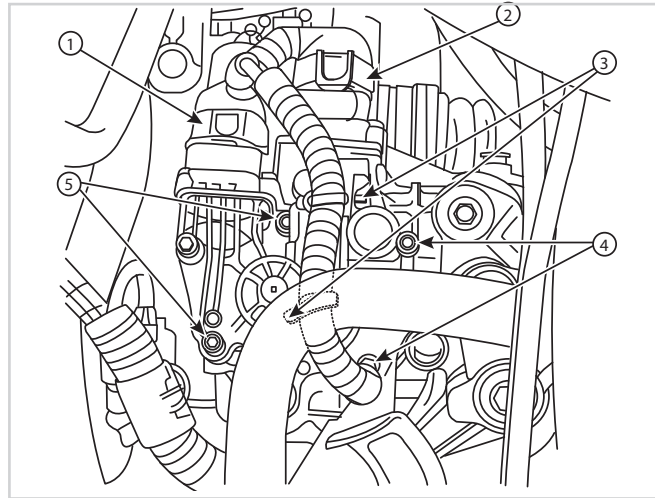
5. Unlock and remove the wiring harness plugs "1" and "2" from the gear selector.
6. Loosen the cable tie "3".
7. Remove the bolts "4" and "5".
8. Lift the gear selector and tilt it forward to remove it.
9. Clean the sealing surface and the threaded holes where the shift module is mounted on the gearbox.

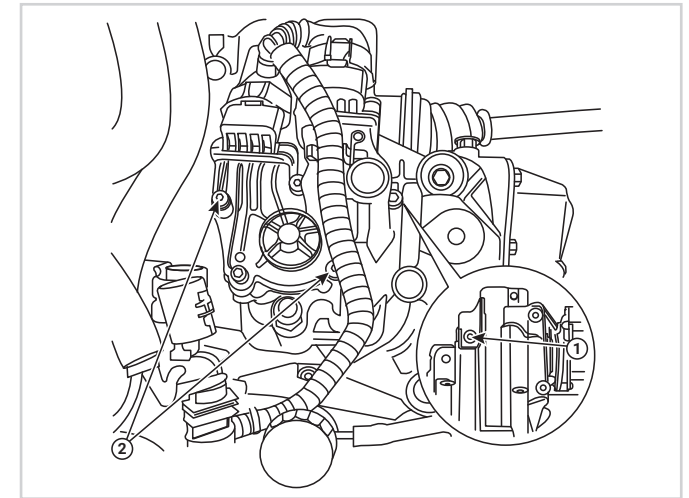
If removal is not possible

If it is not possible to remove the actuator (e.g. due to a defect or external cause) as described below, consider both shift motors as separate components. Proceed as follows:

1. Remove the bolts "1" of the 1st shift motor.
2. Remove the 1st shift motor.
3. Remove the screws "2" of the 2nd shift motor.
4. Remove the 2nd shift motor

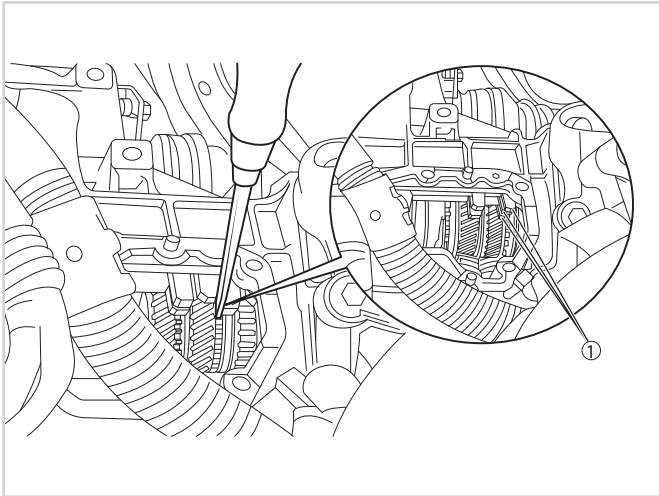
**Only perform in case of a defective gear selector**

Should the gear selector have to be removed because it is defective, then it is necessary to carry out an extra step:

1. Move the gearbox to neutral by allowing the selector forks "1" to coincide: use a screwdriver to move the selector forks.
2. Reverse gear must not be engaged.

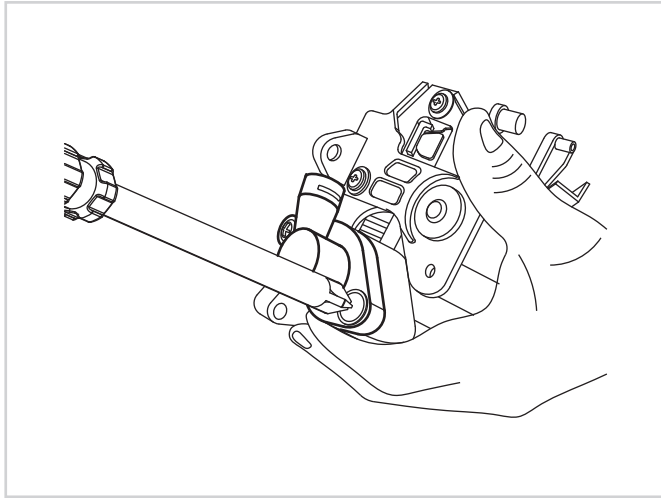
1. Pull the piston rod all the way out, as shown by the red arrow in the illustration.
2. Place the clutch pump on the TCU.
3. Screw the clutch pump hand-tight.
4. The piston rod must be clamped back onto the drive rod. By applying air pressure to the pump outlet, the piston pushes the piston rod back onto the drive rod. You will hear a click when the clutch locks securely.

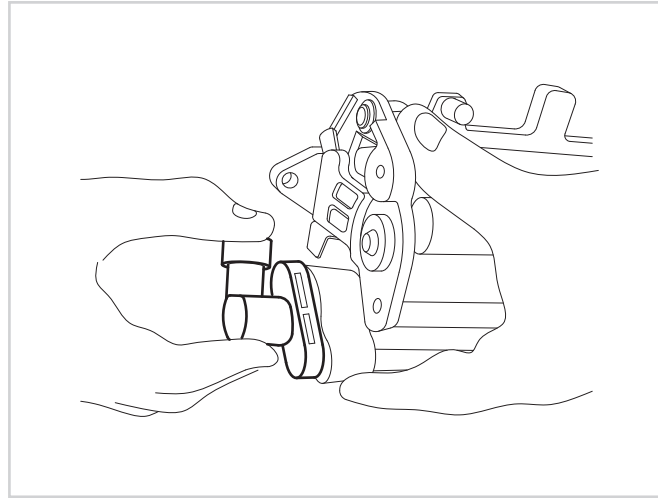
6. Now carefully pull out the clutch pump as indicated by the red arrow.

If the piston rod is **mounted correctly**, the pump can now only be pulled out of the TCU a small distance: resistance can be felt.

The piston rod is **not properly mounted** if the pump is easily pulled out of the TCU.

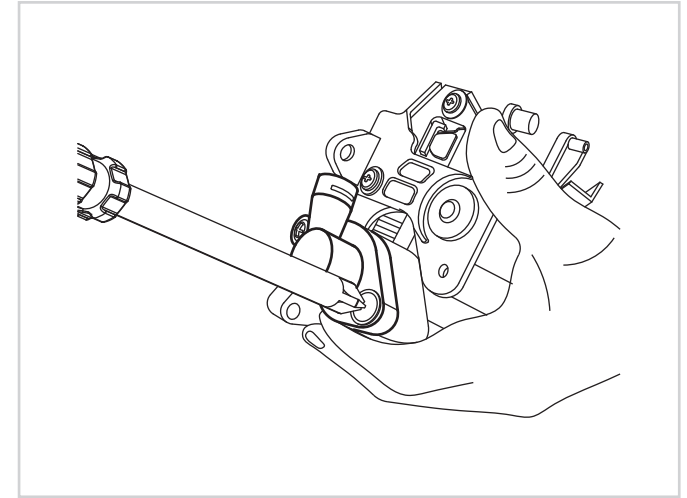
7. Has it been established that the piston rod is correctly mounted? Then finally screw the clutch pump in place.
