DIAGNOSIS GUIDE

TRANSMISSION CONTROL UNIT

**ALL RELEVANT INFORMATION
IN ONE GUIDE**

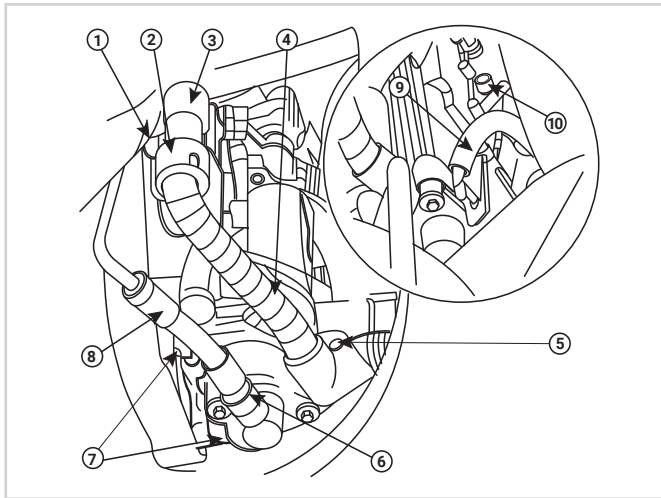
The Easytronic

1. Fasten the Easytronic with bolts "1", "7" and "10". Tightening torque: 11 Nm.
2. Push the brake fluid supply hose "8" onto the connection of the clutch actuator as far as it will go.
3. Press the clutch pressure line "6" firmly onto the clutch actuator connector until you hear and feel a click.
4. Connect the wiring harness plug "2" to the Easytronic and lock the plug.
5. Re-attach the wiring harness holders "4" and "5".
6. Mount the lower engine panelling (if applicable).
7. Connect the wiring harness plug "3" to the Easytronic and lock the plug.

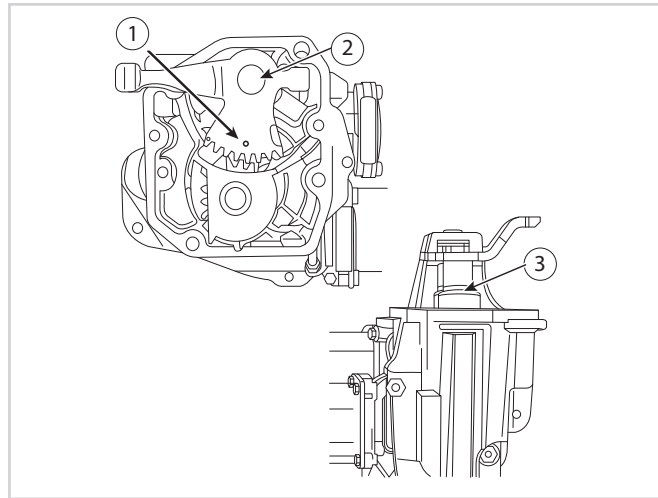
The gear selector

1. Align the marking "1" of the shift shaft "2" with the pinion of the shift motor.
2. Set the shift axle to the neutral position. Groove "3" is then visible and in line with the collar of the bushing.

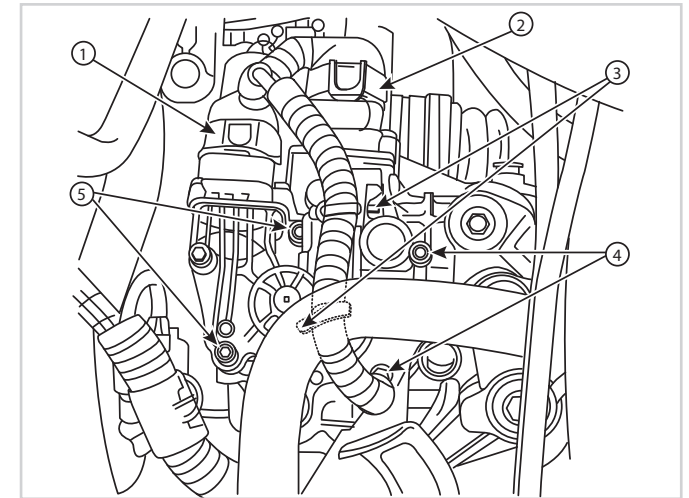
3. Fit the gear selector with a **new** gasket and fit four **new** bolts in places "4" and "5". Tightening torque: 11 Nm.
4. Re-attach the wiring harness plugs "1" and "2" to the gear selector. (The fit of both plugs is different, so it is not possible to confuse them)
5. Secure the wiring harness with 2 cable ties in place "3".

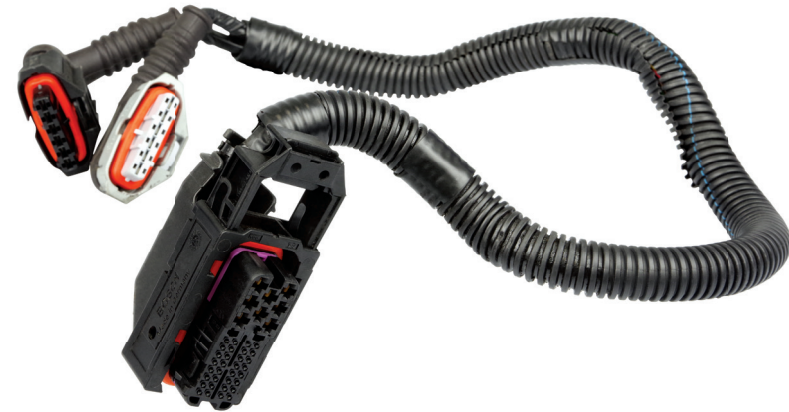
PIN ASSIGNMENT FOR CONNECTOR 1 OF THE TCU (C-676)

Pin 45	K-line
Pin 47	Power supply 12V +15
Pin 48	Ground 31
Pin 49	Power supply 12V +30
Pin 52	Brake light switch
Pin 54	CAN high
Pin 56	CAN low
Pin 57	Complement from pin 74 (interspersed with ecu check pulses)
Pin 59	Front door alarm switch
Pin 61	Link CAN high
Pin 63	Link CAN low
Pin 74	Manual position = pulse train to 12V Auto position = pulse train to 10V
Pin 76	Data burst signal
Pin 77	Clock burst signal
Pin 78	Start signal

The pin numbers in **bold** refer to the selector lever, which can be used to change gears manually if necessary. See also the wiring diagram for both types (2-wire or 4-wire).

A pulse train to 12V must be visible on pin 74 in manual mode. In automatic mode, the pulse train must drop to 10V.

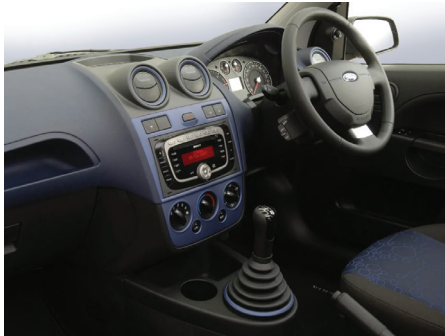
GENERAL OPERATION

The Durashift system is a so-called robotised manual gearbox based on Ford's iB5 five-speed manual gearbox. The Durashift gearbox allows both automatic shifting and shifting with the selector lever. In both cases, the clutch is operated automatically.

For hydraulic disconnection, an electric motor drives a hydraulic pump in the clutch actuator. The gearbox shifts via the two electric motors in the gearbox

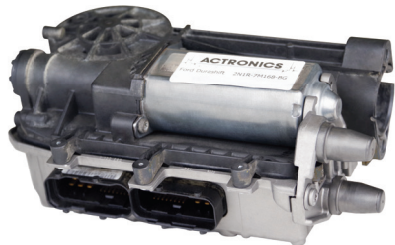
Durashift is the name of the mechatronics that control the clutch and the gear selector. The component consists of a TCU, a clutch actuator and an electric motor.

The most vulnerable part of the Durashift is the clutch actuator. It is mounted in a plastic housing and can quickly start leaking. If you suspect that the clutch actuator is leaking, carry out the official bleeding procedure at all times (see at page 124). The clutch actuator will certainly leak if it is defective.

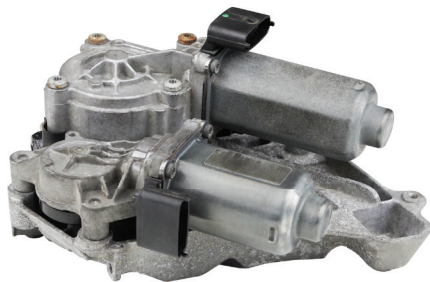
The gear selector consists of two electric shift motors. These shift motors are used to select the gears. As explained above, both motors are controlled by the TCU, which is located in the Durashift.

The gear selector is still controlled in the "old-fashioned" way by the TCU. This means that CAN messages are not used, but power, ground and signals for direction and time are used. Because both signals are necessary to activate these "smart" electric motors, it is unfortunately not possible to connect power and ground to test the electric motors yourself.

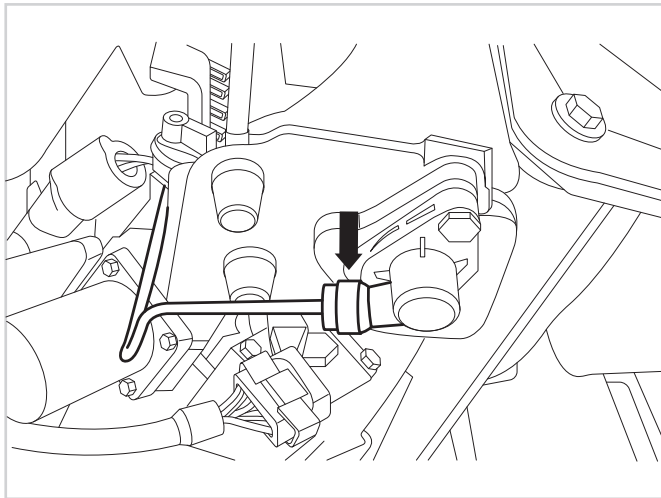
The Durashift is mounted in the engine compartment on the side member at front left.

1. Remove the cover of the hydraulic fluid reservoir.
2. Release and remove the wiring harness plug from the Durashift.
3. Place a container to catch the brake fluid.
4. Remove the spring clip from the brake fluid supply hose and pull out the brake fluid supply hose. Collect the escaping brake fluid.

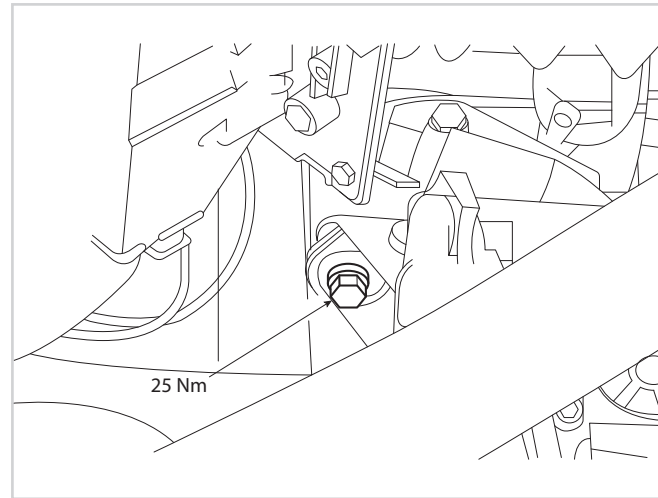
5. Remove the torque limiter and the TCU together by loosening the torque limiter bolt.

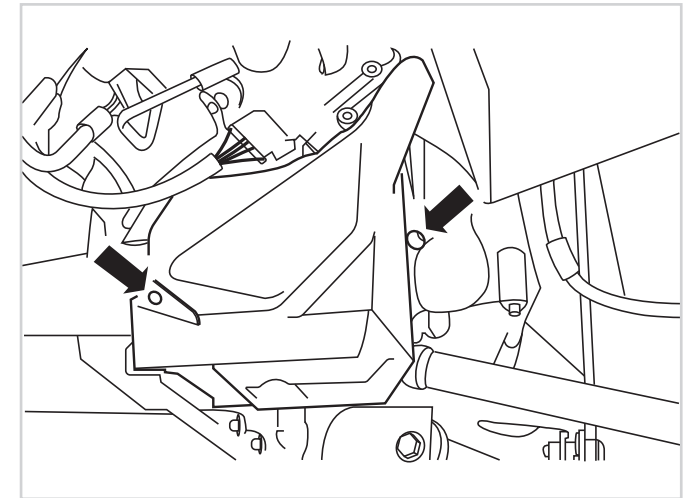
The gear selector is best disassembled from below. The use of a lift is therefore recommended.

1. Remove the cover of the shift actuator.

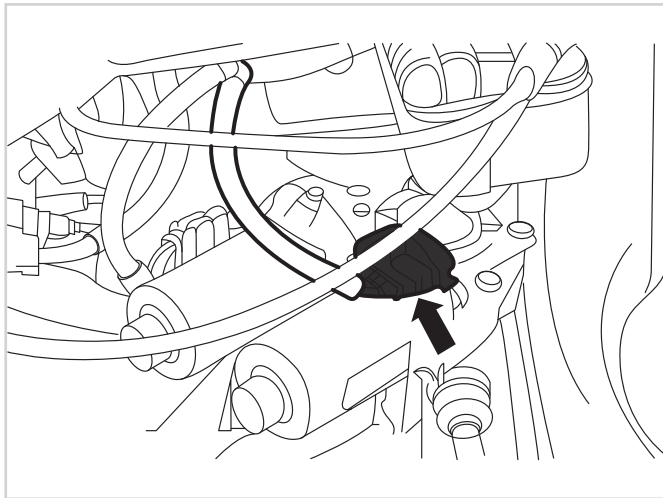
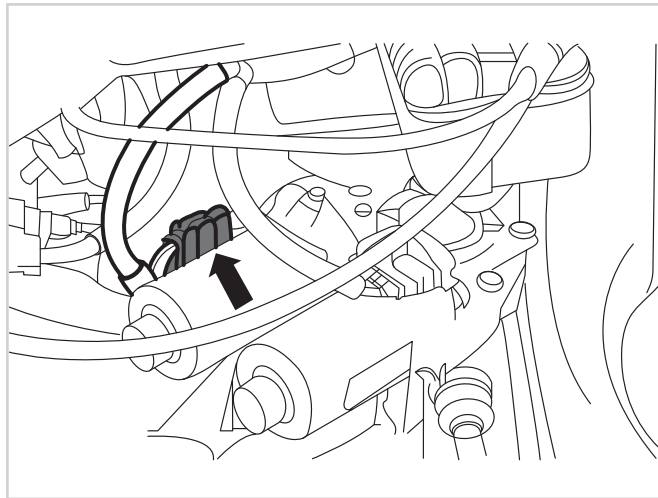
2. Disconnect both plugs from the shift actuator: the black plug is on top of a shift motor, the grey plug is blocked on the side of a shift motor. See illustrations above.

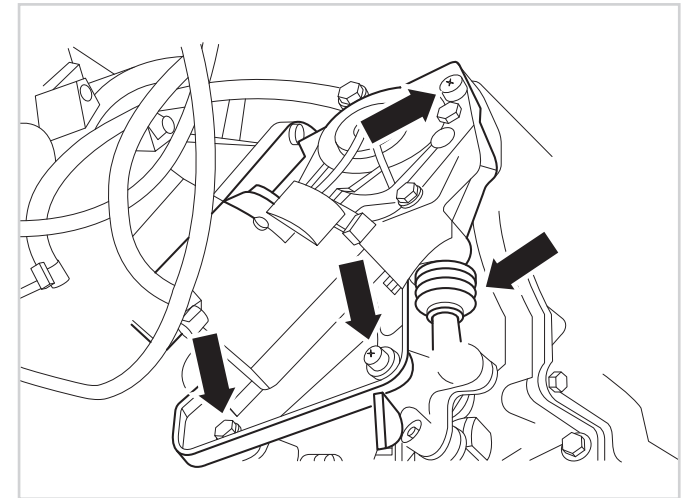
3. Click the black "bowl" of the control rod out of the "sphere" of the ball coupling.
4. Loosen the three fixing bolts and remove the shift actuator with base plate from the gearbox.

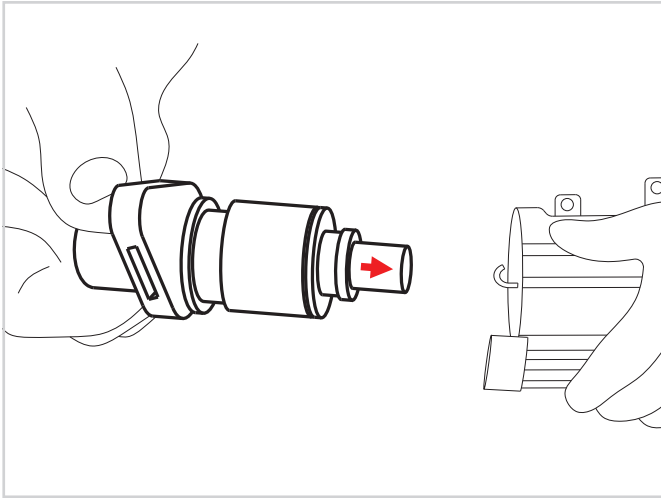
1. Pull the piston rod all the way out, as shown by the red arrow in the illustration.
2. Place the clutch pump on the TCU.

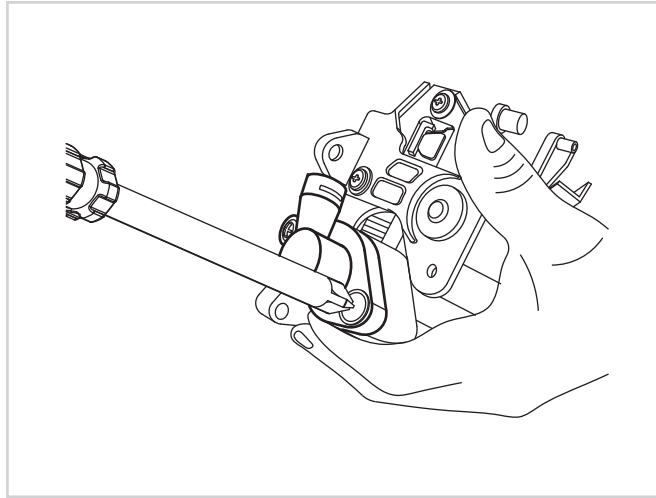
3. Screw the clutch pump hand-tight.

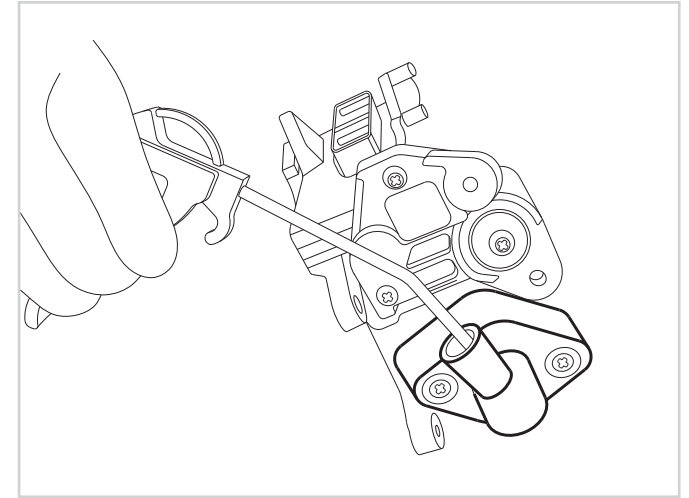
4. The piston rod must be clamped back onto the drive rod. By applying air pressure to the pump outlet, the piston pushes the piston rod back onto the drive rod. You will hear a click when the clutch locks securely.

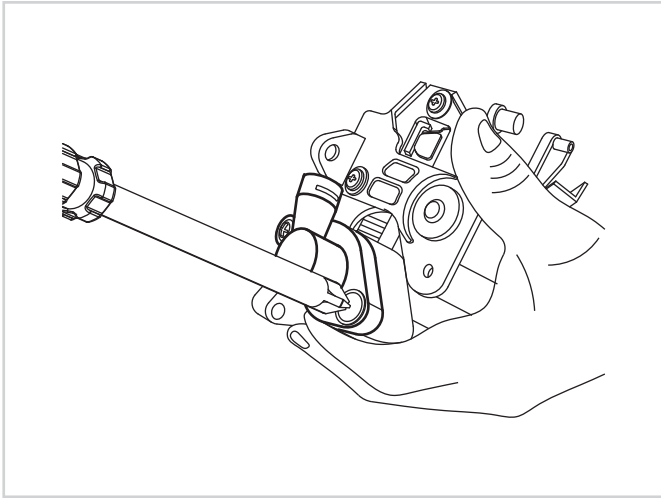
5. Remove the clutch pump screws.

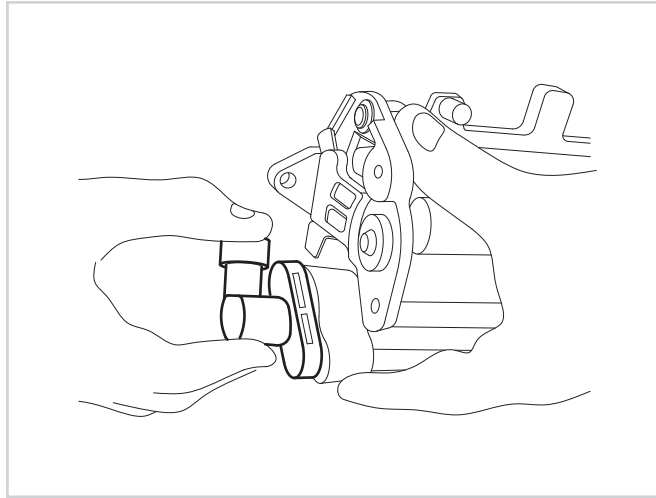
6. Now carefully pull out the clutch pump as indicated by the red arrow.

If the piston rod is **mounted correctly**, the pump can now only be pulled out of the TCU a small distance: resistance can be felt.

The piston rod is **not properly mounted** when the pump is easily pulled out of the TCU.

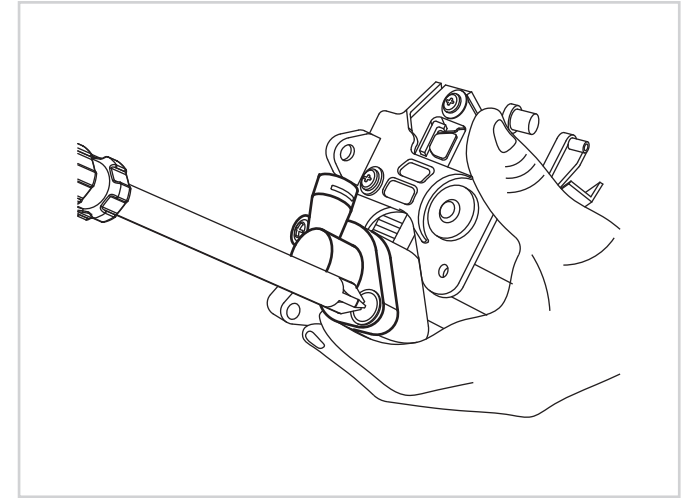
7. Has it been established that the piston rod is correctly mounted? Then finally screw the clutch pump in place.

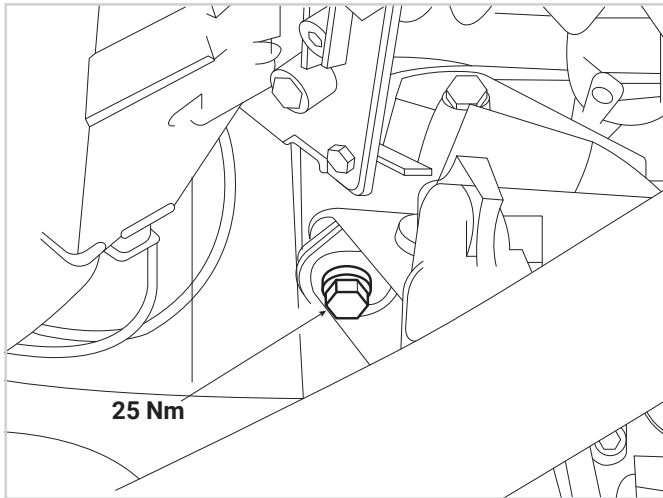
1. Assemble the torque limiter and the TCU together by tightening the torque limiter bolt. Tightening torque: 25 Nm.

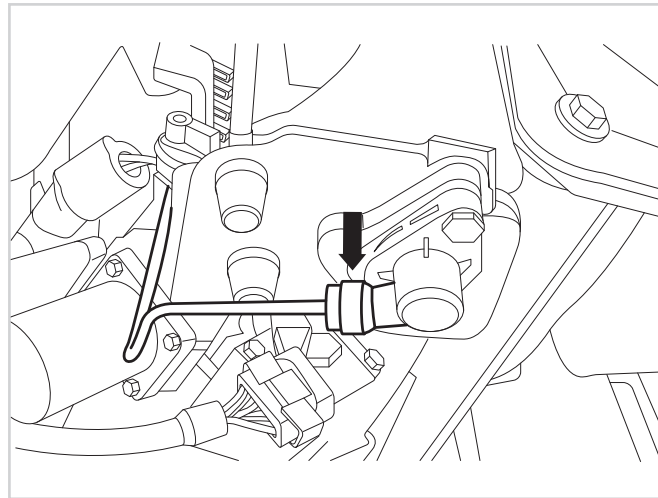
2. Replace the brake fluid supply hose on the connection and mount the spring clip.
3. Install the wiring harness plug of the Durashift.

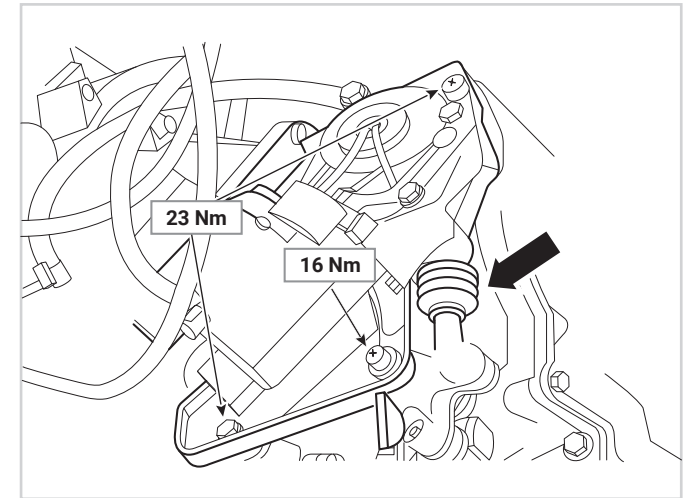
1. Mount the gear selector by tightening the 3 bolts. See illustration for correct tightening torques.
2. Click the black "bowl" of the control rod back on the "sphere" of the ball coupling.

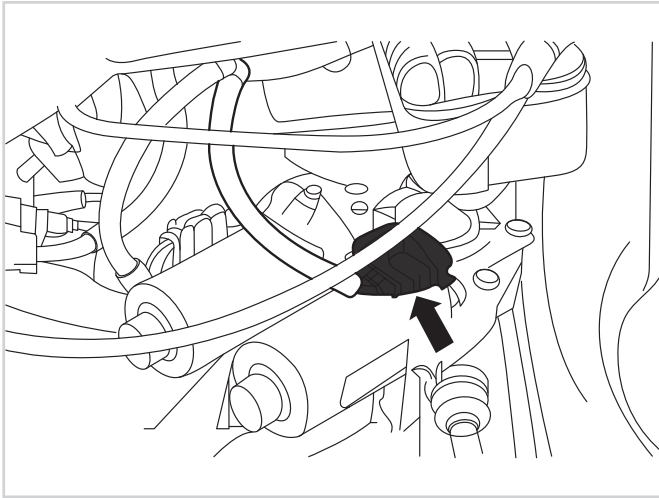
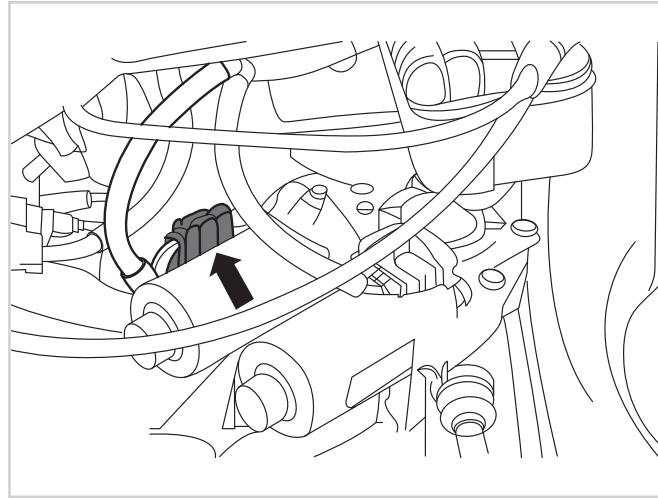
3. Attach both plugs to the shift actuator: the black plug belongs on top of a shift motor, the grey plug belongs on the side of a shift motor. See illustrations above.

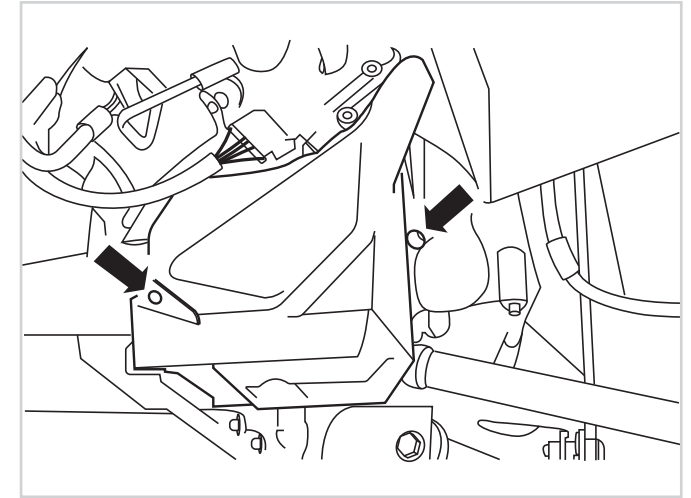
4. Install the cover of the shift actuator.

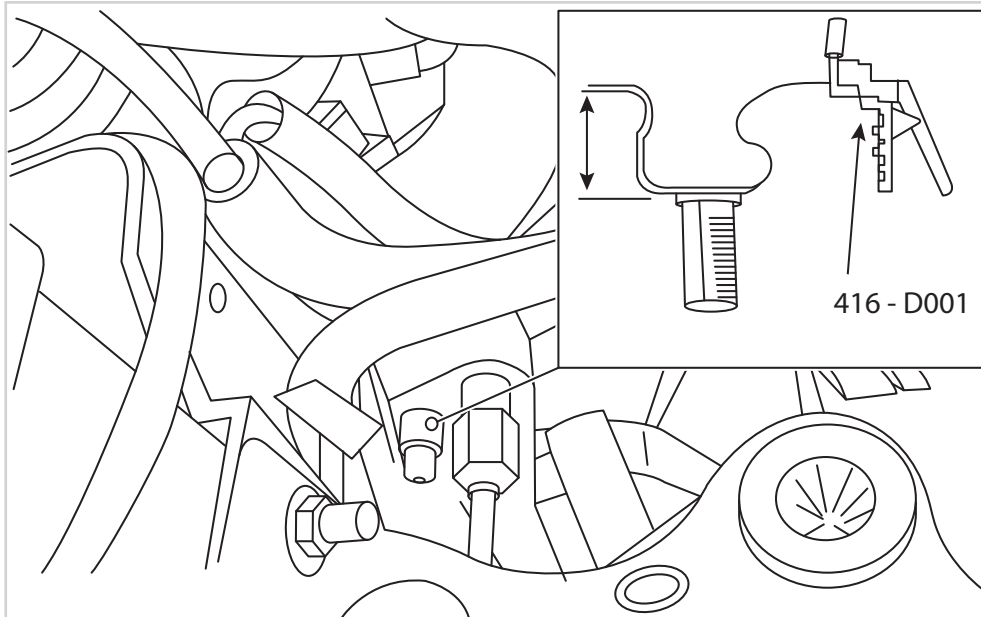
1. Check the level in the brake fluid reservoir.
2. If necessary, top up with DOT4 brake fluid to the "MAX" mark on the reservoir.
3. Connect the suction line of the manually operated fluid pump to the plastic bleed nipple.

The bleed nipple can be opened and closed by hand or with a spanner. Make sure that the reservoir of the manual fluid pump is below the level of the bleed nipple during bleeding (see illustration).
